Milestone Inspection Report

Project #23RS-0013
July 24th 2023
FINAL COPY

RE: *Longboat Harbour Structural Evaluation*
4454 Gulf of Mexico Drive, Longboat Key, FL 34228
KE File # 23RS-0013
Professional Engineering Services – Milestone Inspection, Structural Integrity Reserve Study

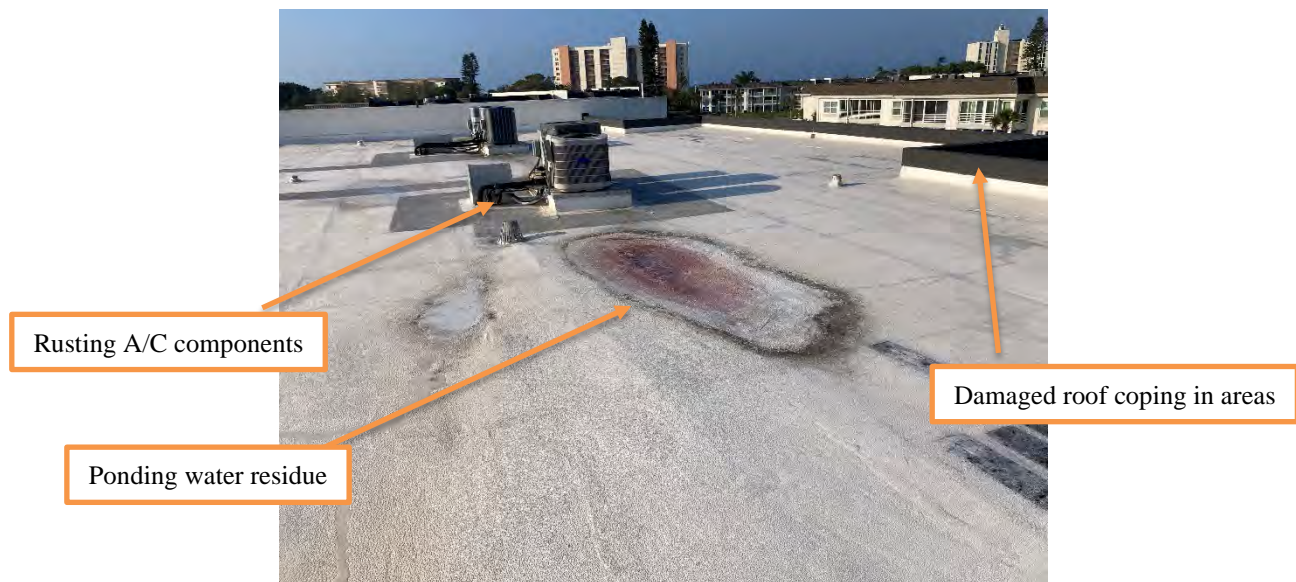
- There is a great presence of rust accumulated on the A/C units across all buildings.
- Ponding water residue is present across all buildings.
- The roof copings surrounding all buildings appear to be aged. Many locations of sealant failures at joints, punctures, and warped sections were observed.
- A slight presence of debris was accumulated on all rooftops.

Figure 9: Typical rooftop overview.

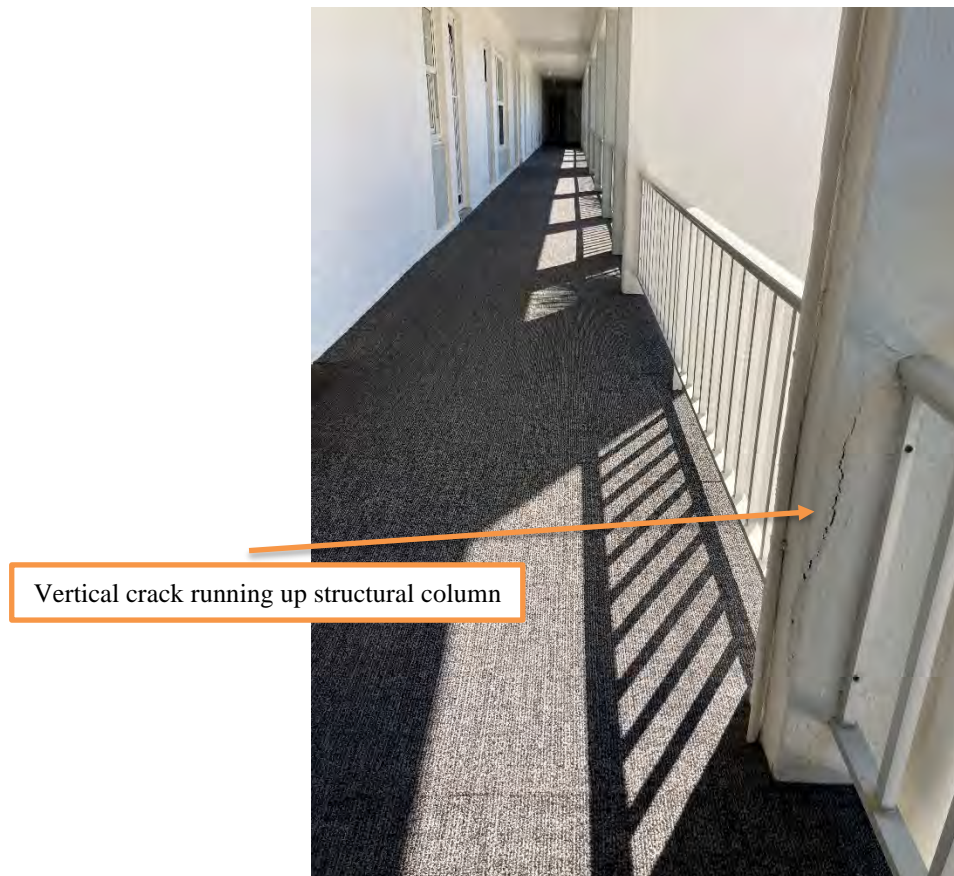
Figure 12: Typical walkway section.

- Locations of cracking were observed in structural columns and beams across the property.

Vertical crack running up structural column

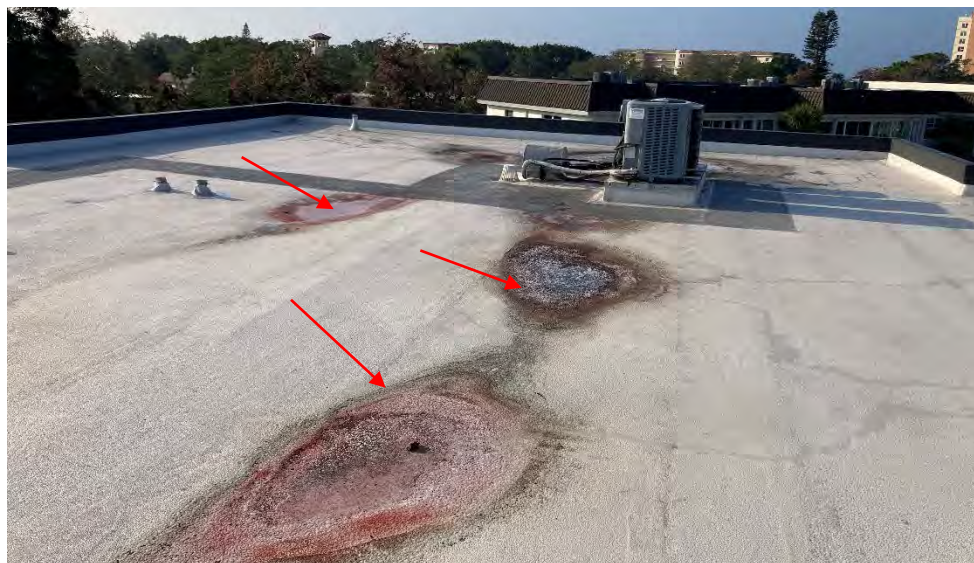
Figure 2 – Ponding residue on rooftops

- A general scrubbing of the rooftop should take place. Ponding residue should be cleaned along with any debris accumulated on the rooftop surface.
 - Ensure that all traction tracks on stair steps in stairwells are secure. Locations of loose tracks were noticed.

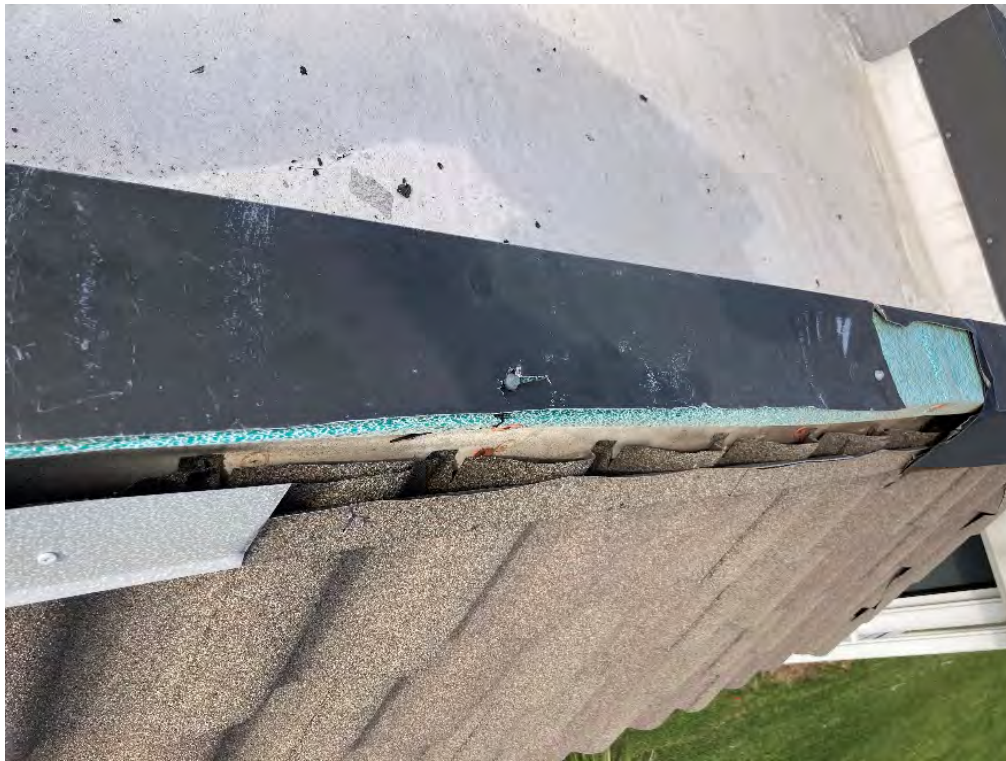
Figure 3 – Damaged coping along rooftop

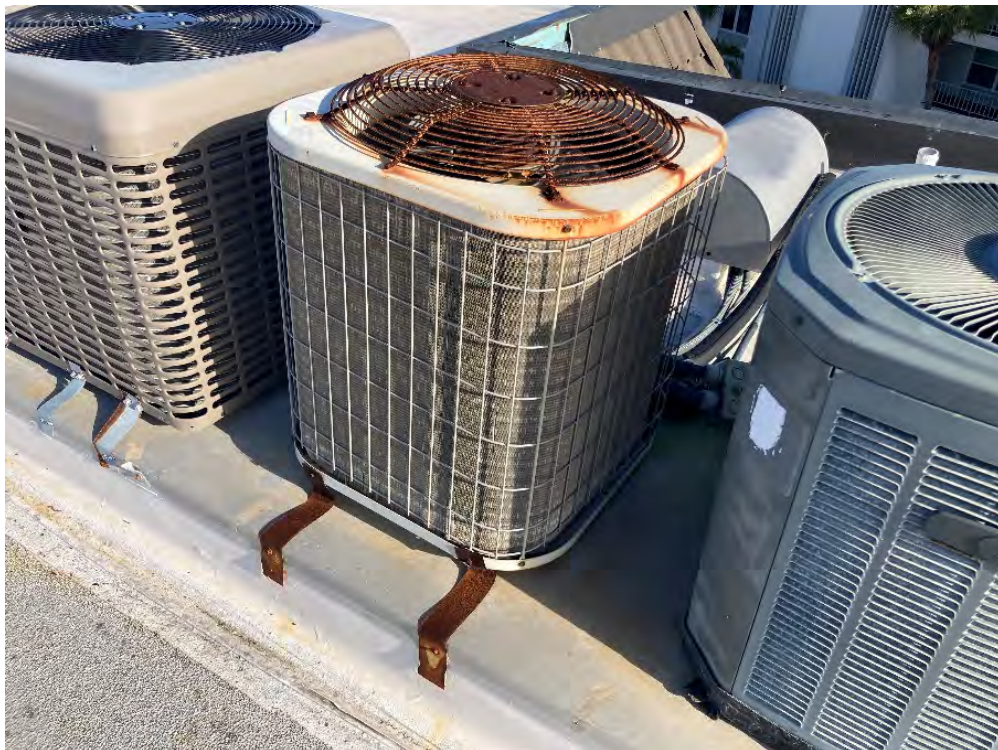
Figure 4 – Rusted A/C components

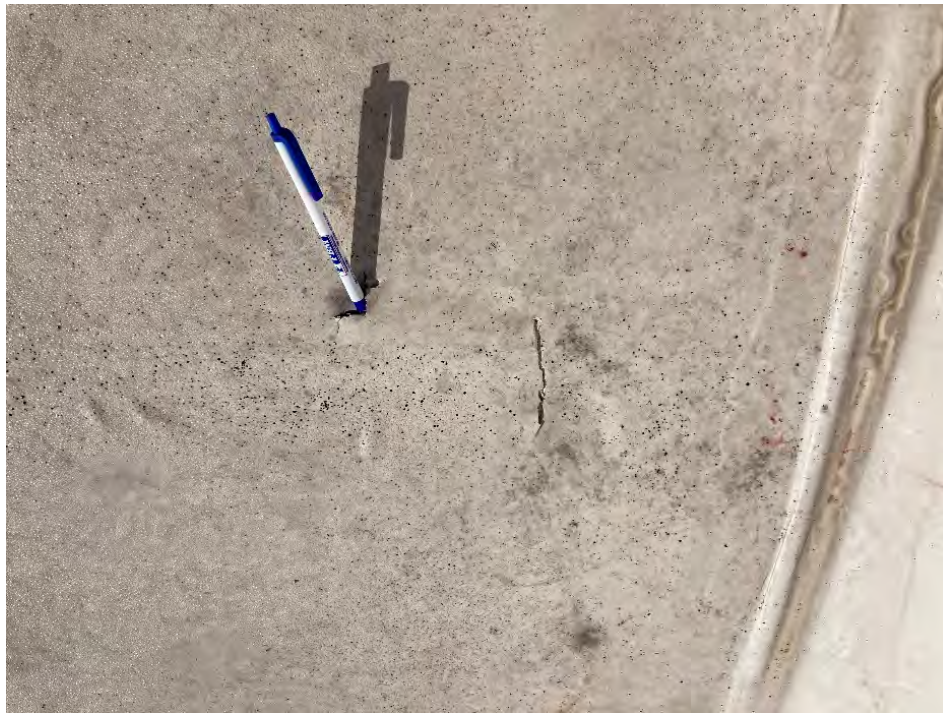
Figure 5 – Punctured TPO membrane

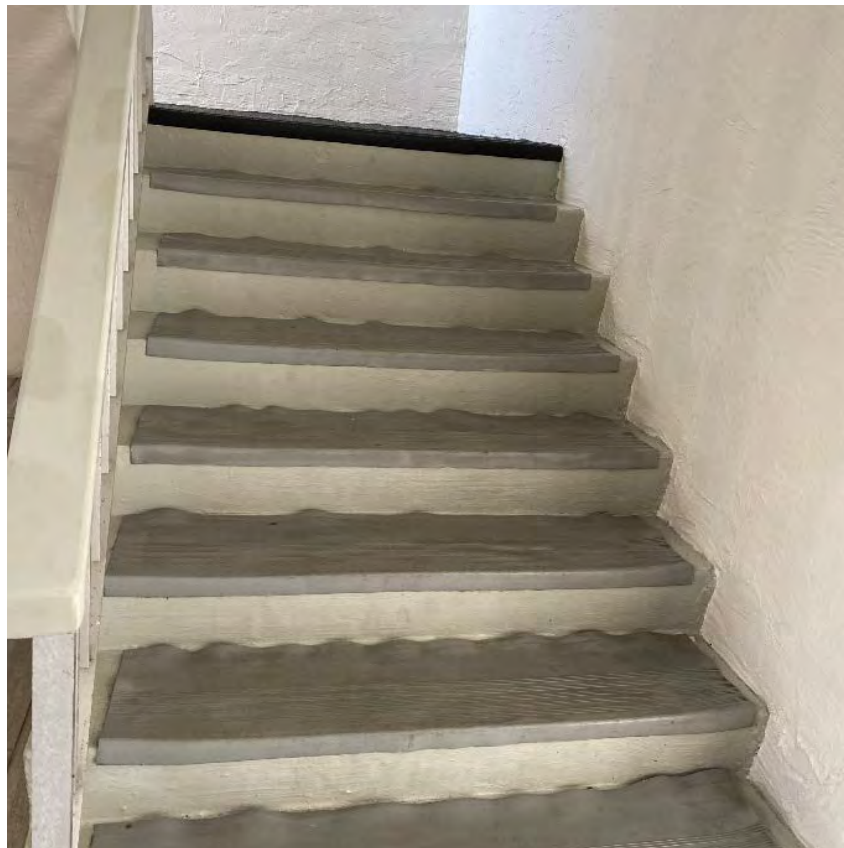
- Traction tracks attached to stair steps appear to be becoming loose in some locations.

Figure 6 – Traction tracks on stairs starting to detach from stairs

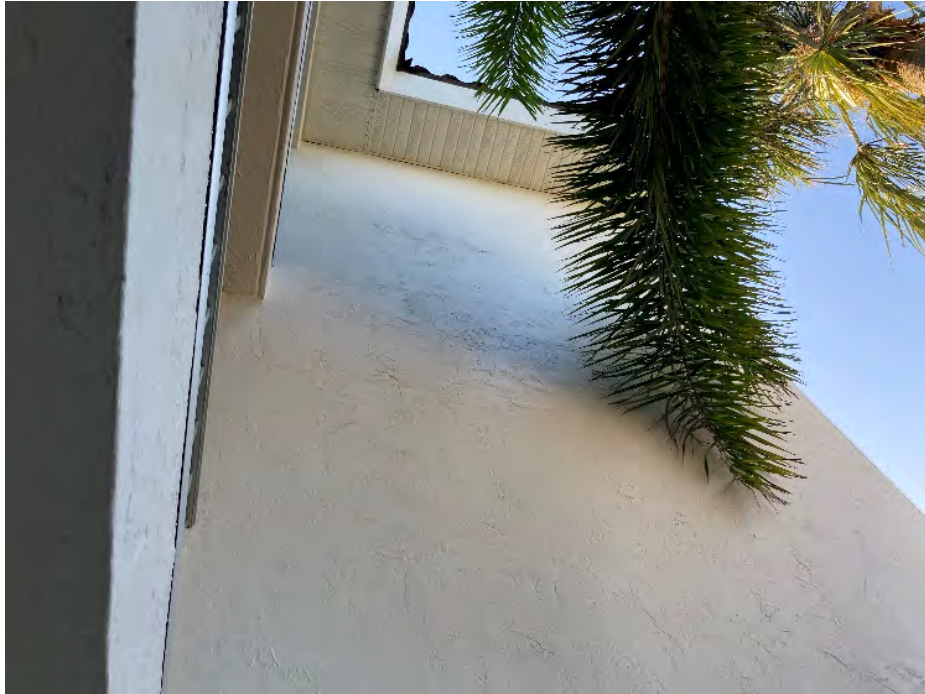
Figure 7 - Plants rubbing against exterior wall, typical

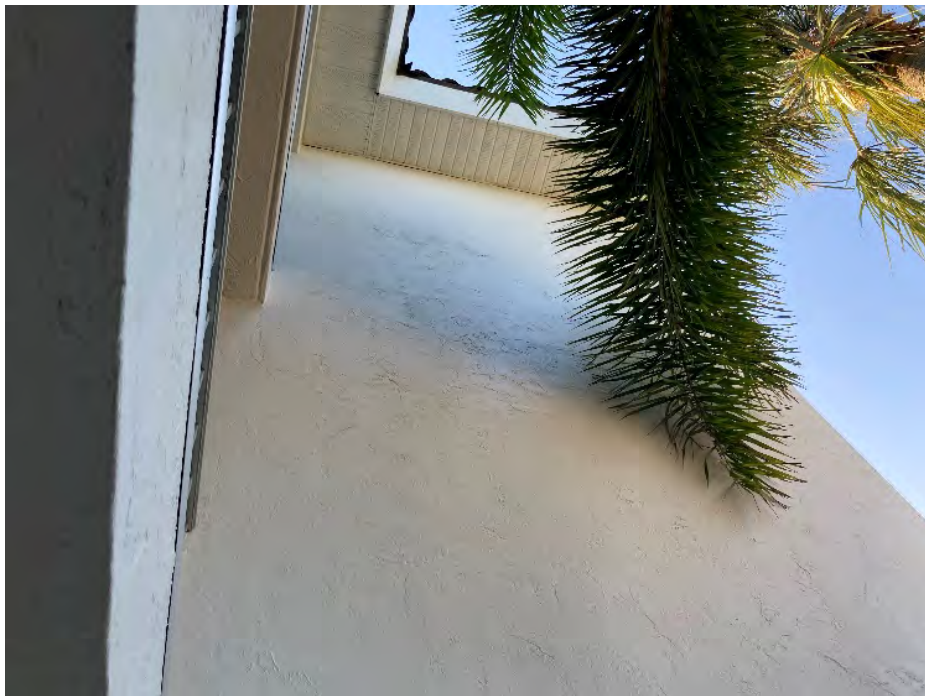
Figure 8 - Plants rubbing against exterior wall, typical

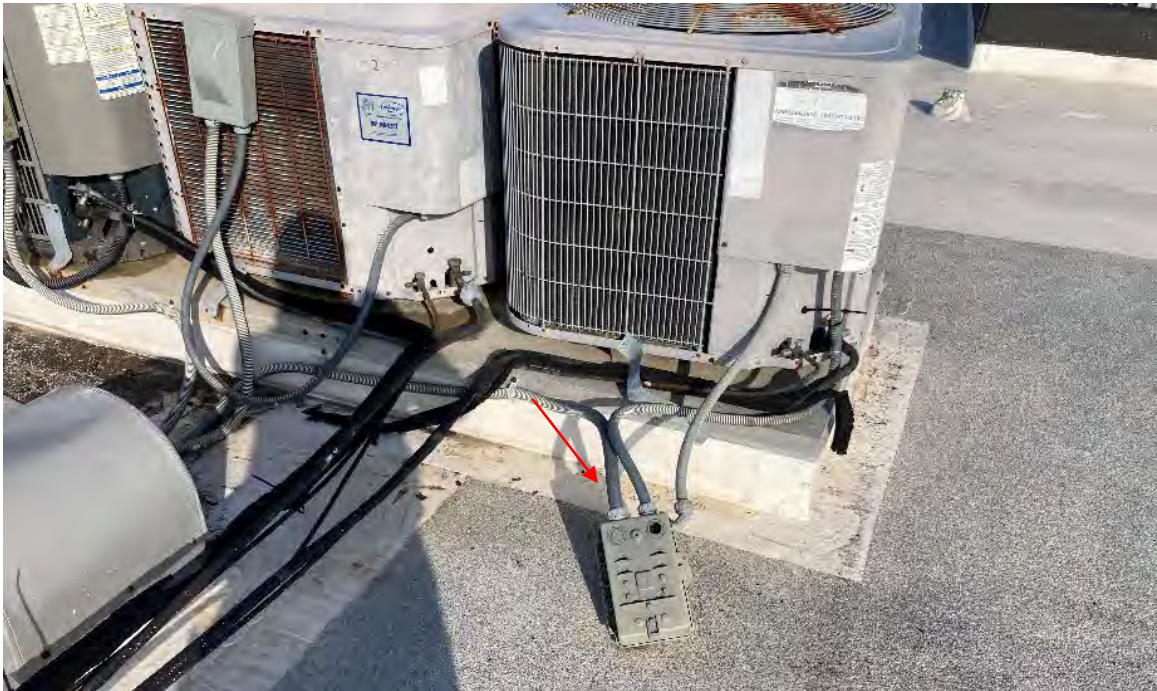
Figure 9 – A/C control box detached from unit

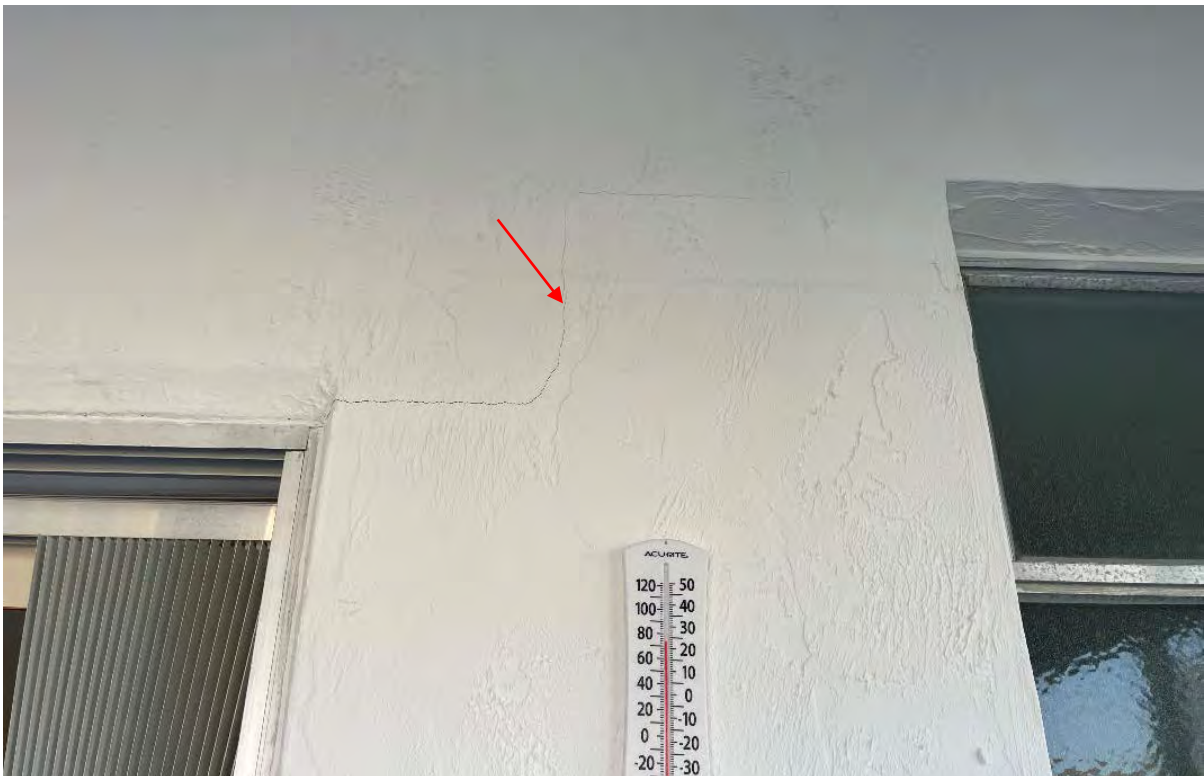
Figure 10 – Stair-stepping in Unit C202

- Evidence of stair-stepping on the balcony CMU wall of Unit C202. Repair in accordance with International Concrete Repair Institute guidelines.
 - A plan should be implemented to review A/C connections on the roof. Many A/C units were noted to have rusted brackets/fasteners.

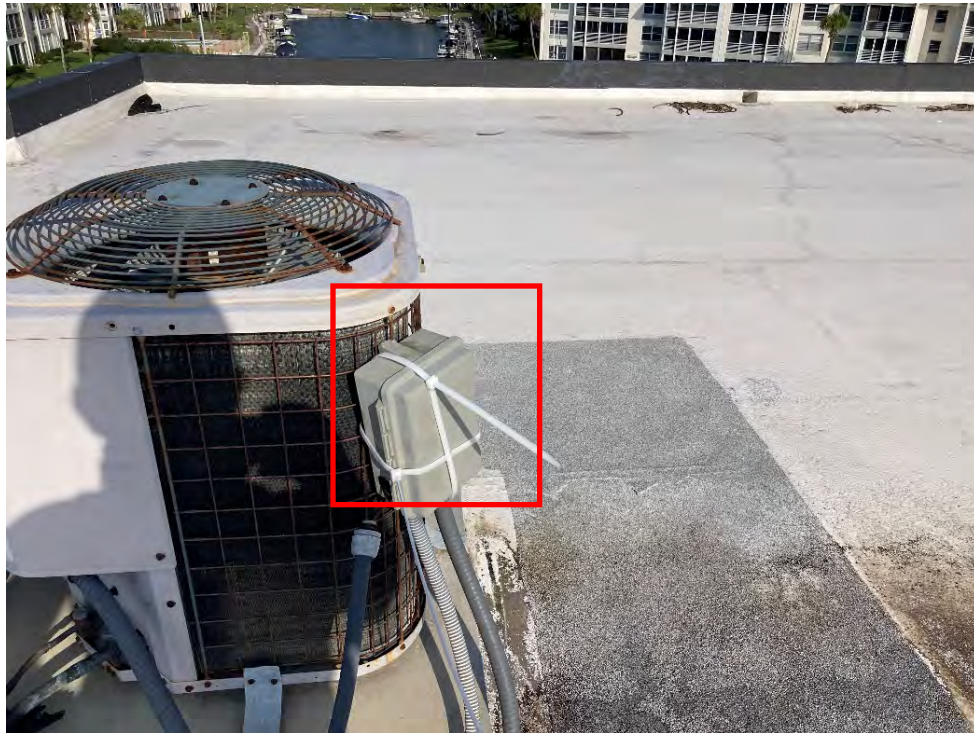
Figure 11 – A/C control box not properly secured

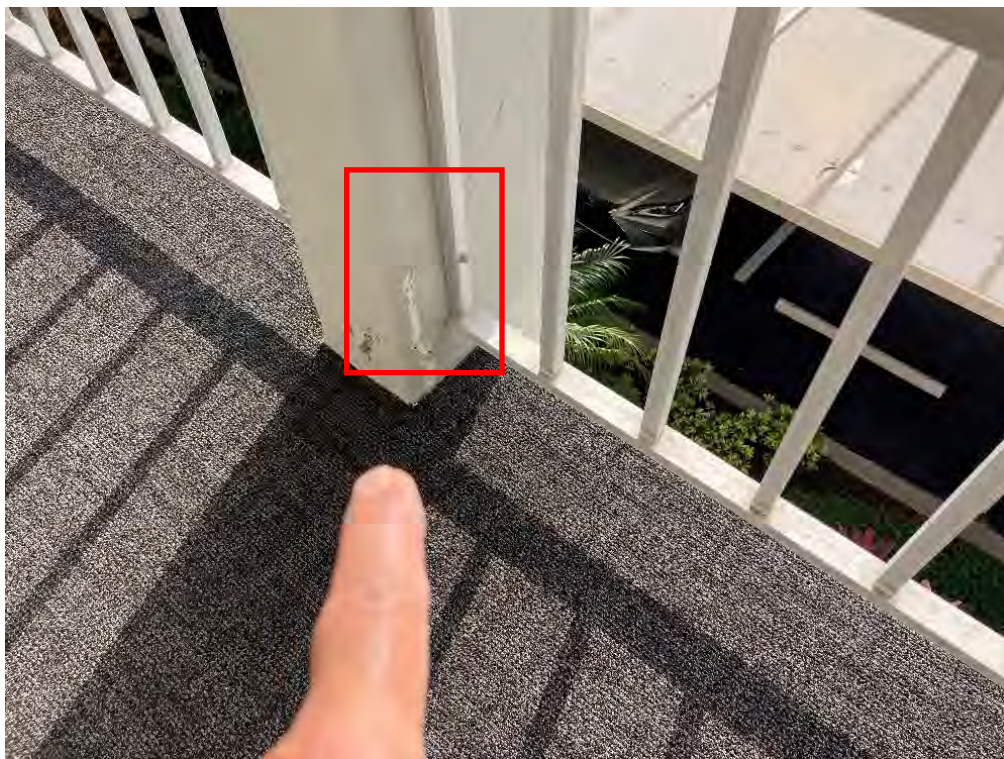
Figure 12 – Paint peeling on column

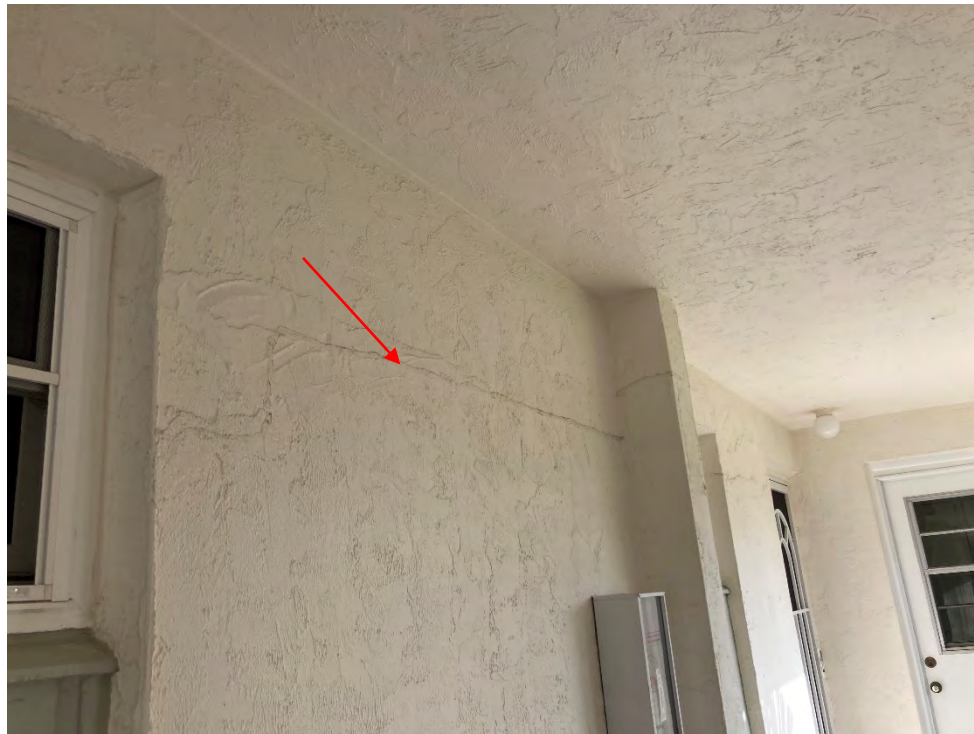
- One location of stair-stepping in a CMU wall was observed on level one.
 - A plan should be implemented to review A/C connections on the roof. Many A/C units were noted to have rusted brackets/fasteners.

Figure 13 – Stairstepping on ground floor

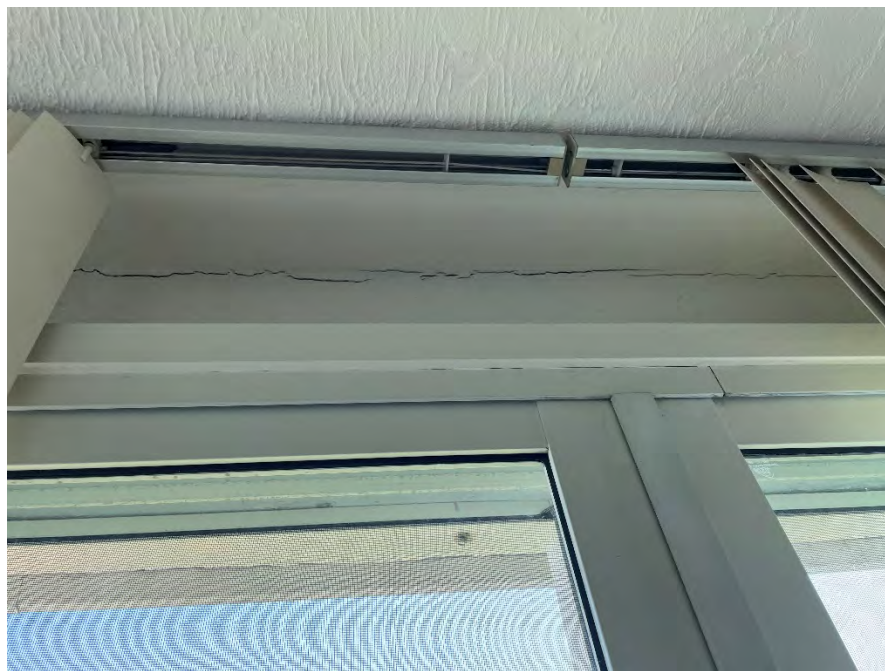
Figure 14 - Cracking of stucco and sealant in Unit E301

- Important and Urgent
 - Review Unit E301 for cracking issues. Multiple locations of cracking were noticed within the unit. Repair using ICRI guidelines.

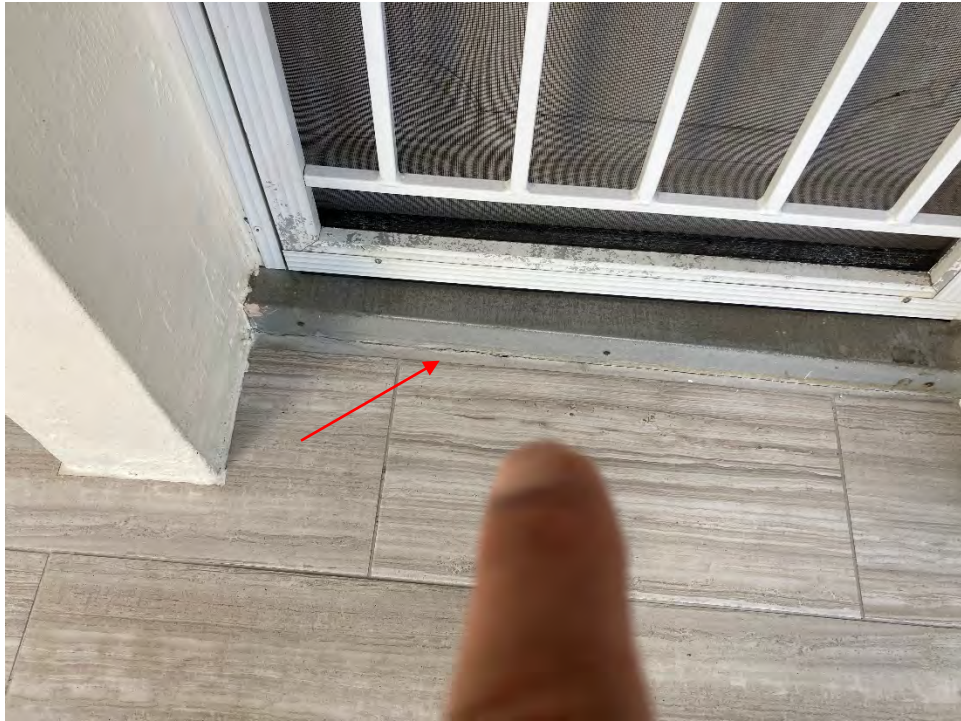
- The TPO in place was observed to be blistered or punctured. A review should take place to address these issues.
 - There appeared to be a crack in the sealant used for the tile around the front door of Unit E105. This could be a potential source for a leak.

Figure 15 – Cracking sealant in front of Unit E105

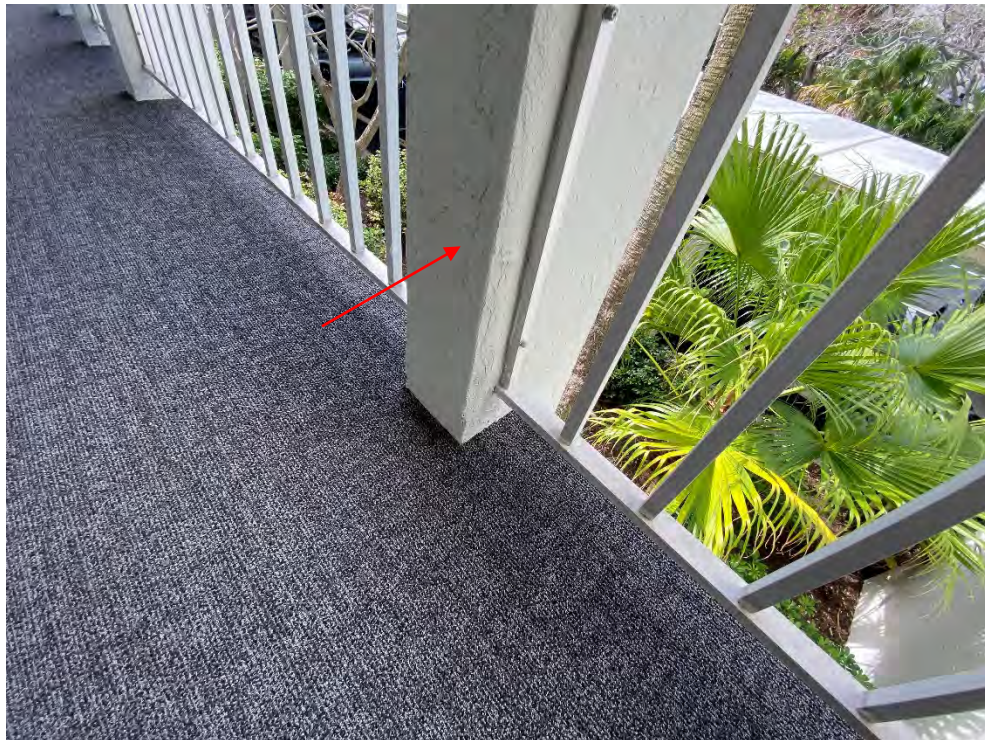
Figure 16 - Cracking in stucco on column on 2nd floor walkway

- Important and Urgent
 - A review of all columns should take place. A location observed was on level two in a column where there appeared to be cracking in the stucco. Repair using ICRI Guidelines.
- Important and Not Urgent
 - A review of the coping on the rooftop should take place. Areas of the coping were observed to be punctured, loose, missing, or warped.
 - The TPO in place was observed to be blistered or punctured. A review should take place to address these issues.
 - A review of the exterior surrounding Unit F308 should take place. A location of a rusting connection plate on the exterior of the balcony was noticed.
 - A review of the balcony of Unit F201 should take place. Locations of ponding water under the balcony carpet and cracking in the concrete supporting the slider were noticed.

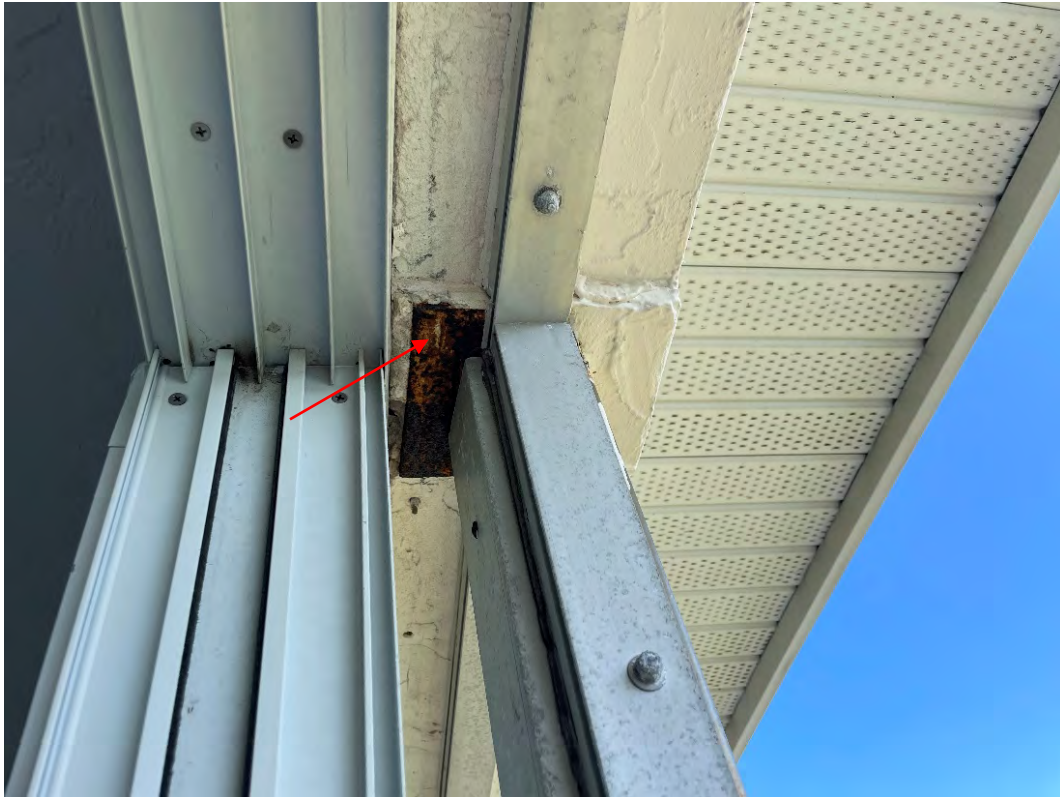
Figure 17 - Rusted connection plate by window of Unit F308

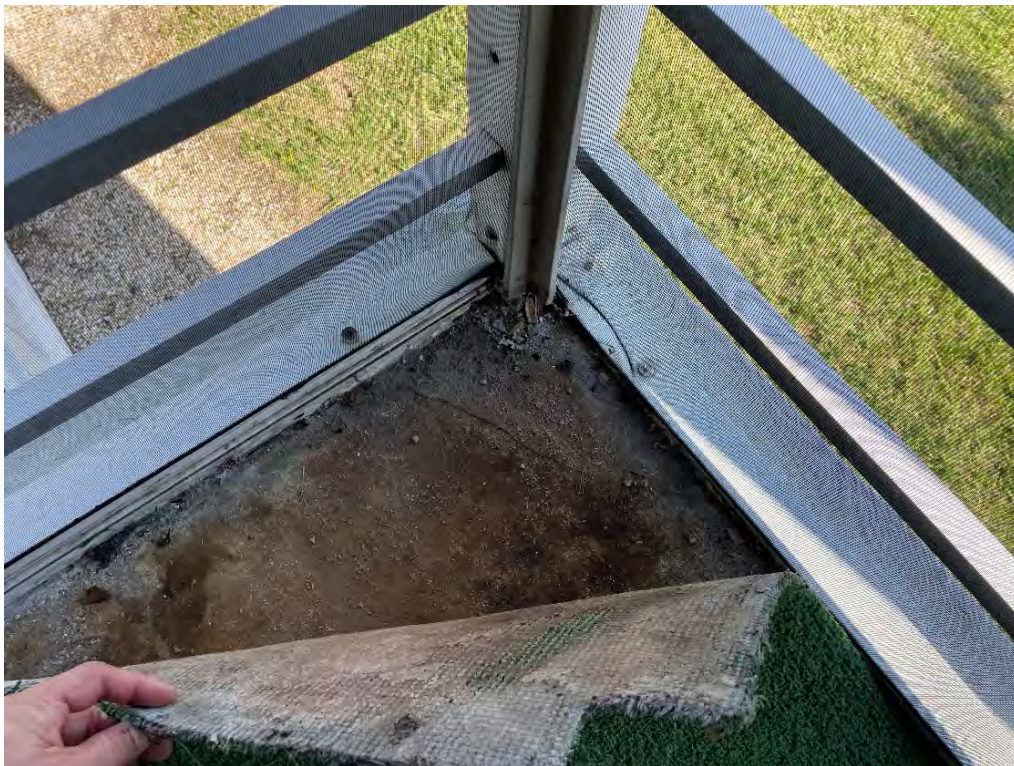
Figure 18 - Water damage under carpet of Unit F201

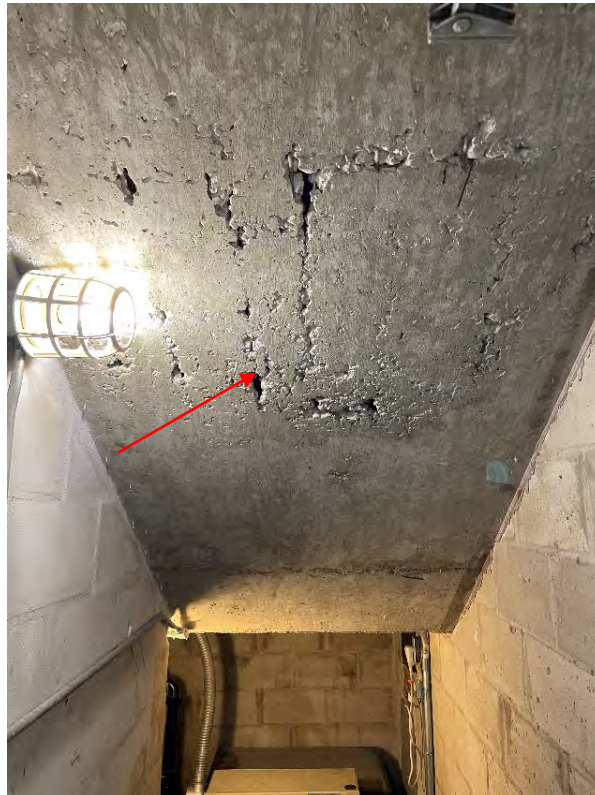
Figure 19 – Honeycombing of concrete in mechanical room

- Important and Not Urgent
 - A review of the mechanical room should take place. Leading down to the mechanical room, the concrete sloped ceiling appeared to be honeycombing. Deteriorating concrete should be addressed with ICRI Guidelines.

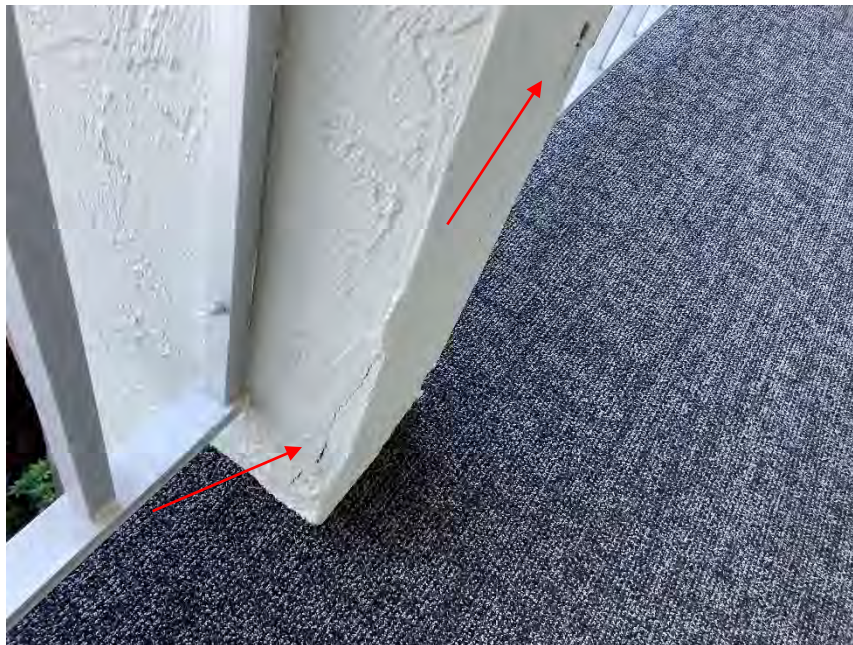
Figure 20 - Locations of potential spalling on column on 3rd floor

- Important and Urgent
 - A review of all columns should take place. One location noticed was on level three where a crack and a potential concrete spall were present on a column. Another location noticed was on level two where a previous repair had occurred. Repair with ICRI Guidelines.

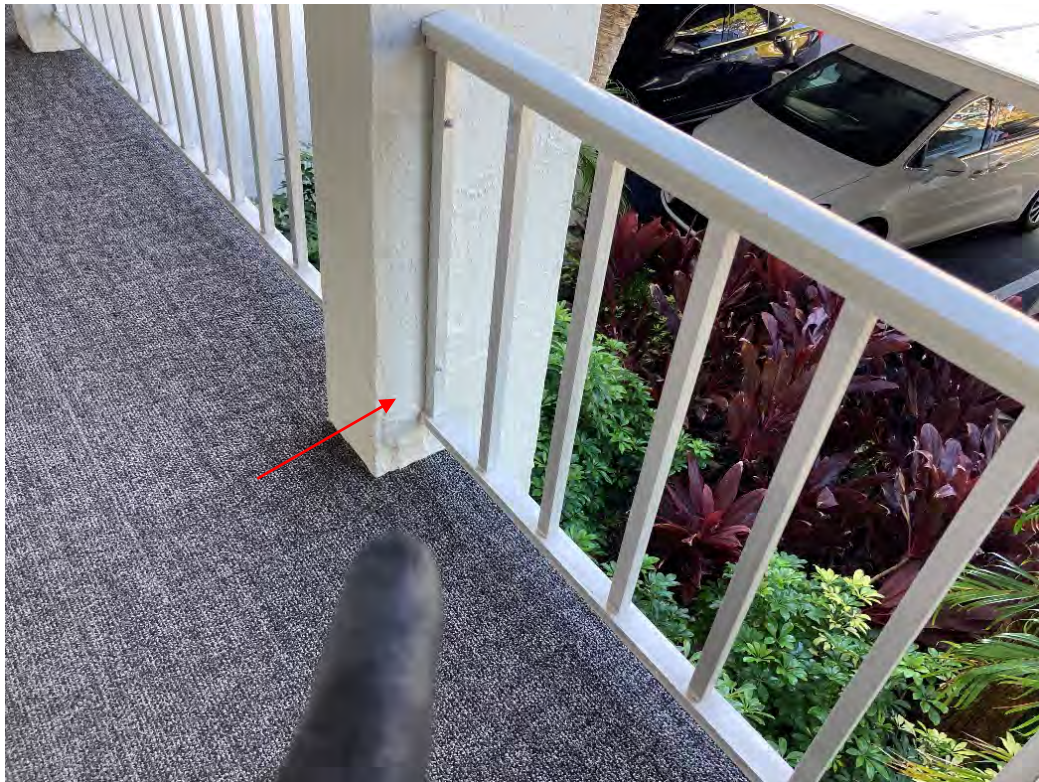
Figure 21 - Previous repair made

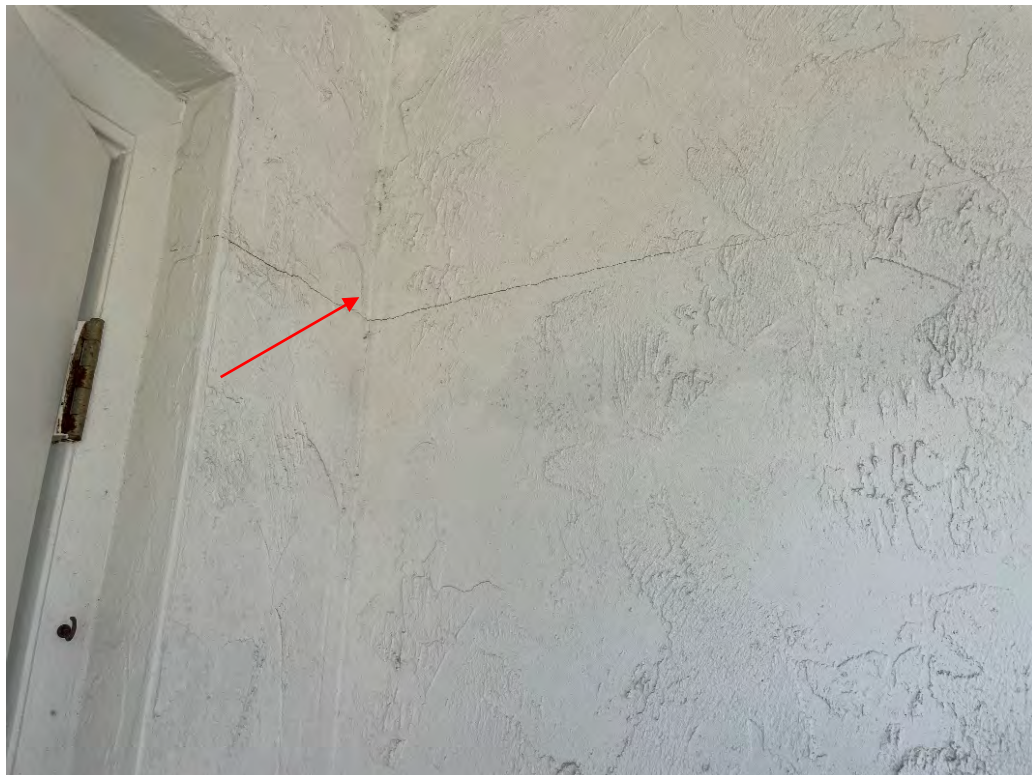
Figure 22 - Stair-stepping in Unit G306

- A review of the balcony in Unit 306 should take place. A location of stair-stepping was observed in the CMU balcony wall.
 - A plan should be implemented to review A/C connections on the roof. Many A/C units were noted to have rusted brackets/fasteners.

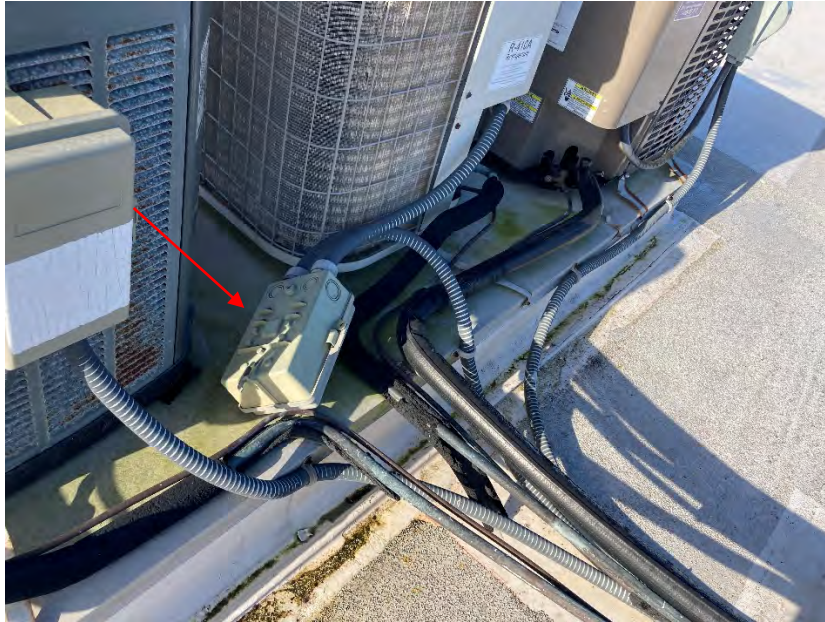
Figure 23 - A/C control box detached from unit

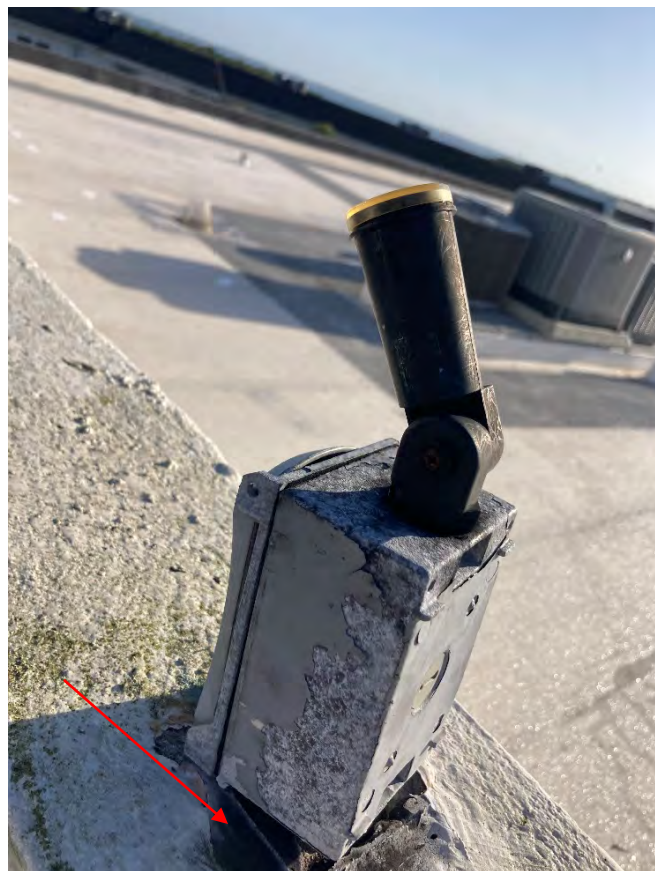
Figure 24 - Extrusion not sealed properly

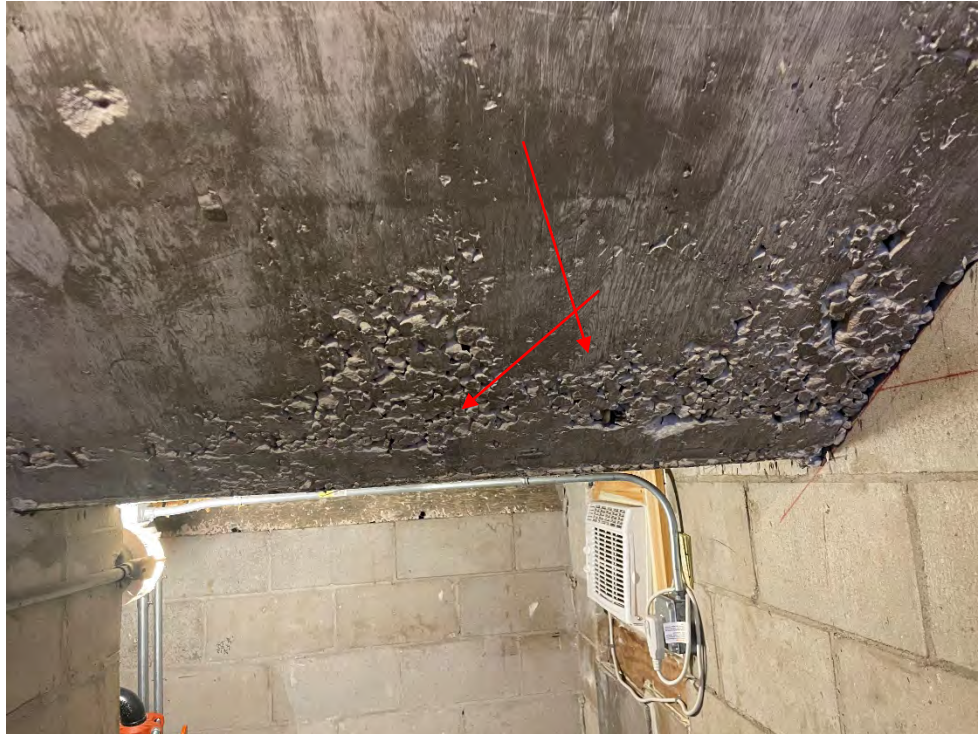
Figure 25 – Honeycombing of concrete in mechanical room

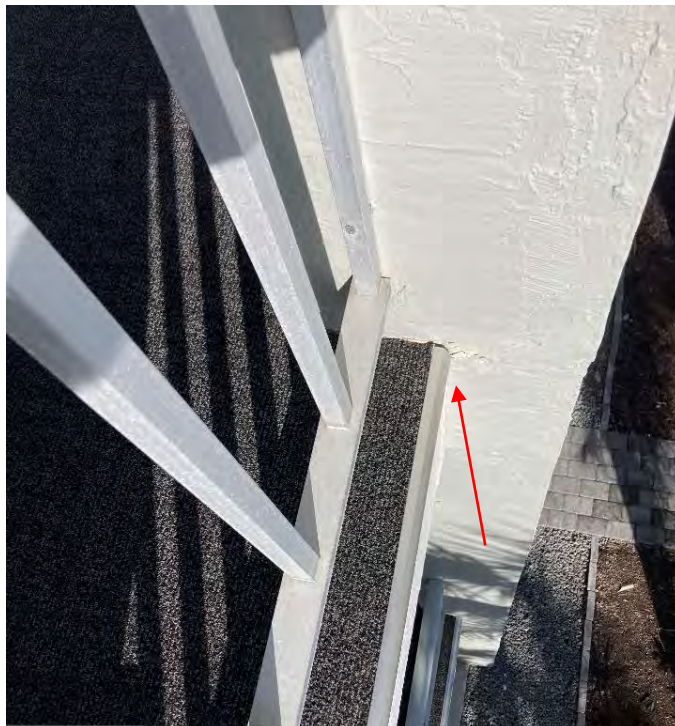
Figure 26 - Paint delamination on column on level three

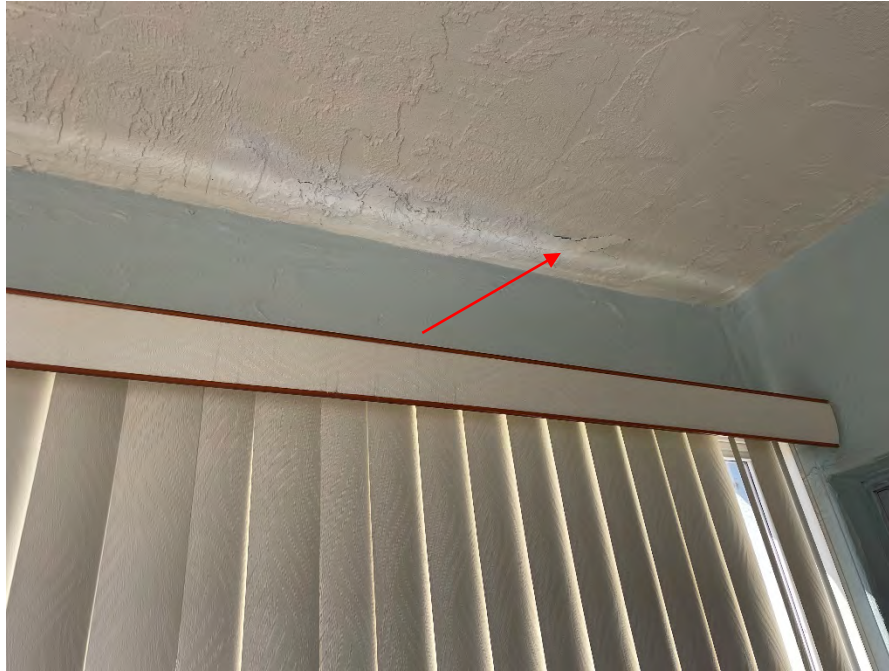
Figure 27 - Cracking in ceiling of unit J203

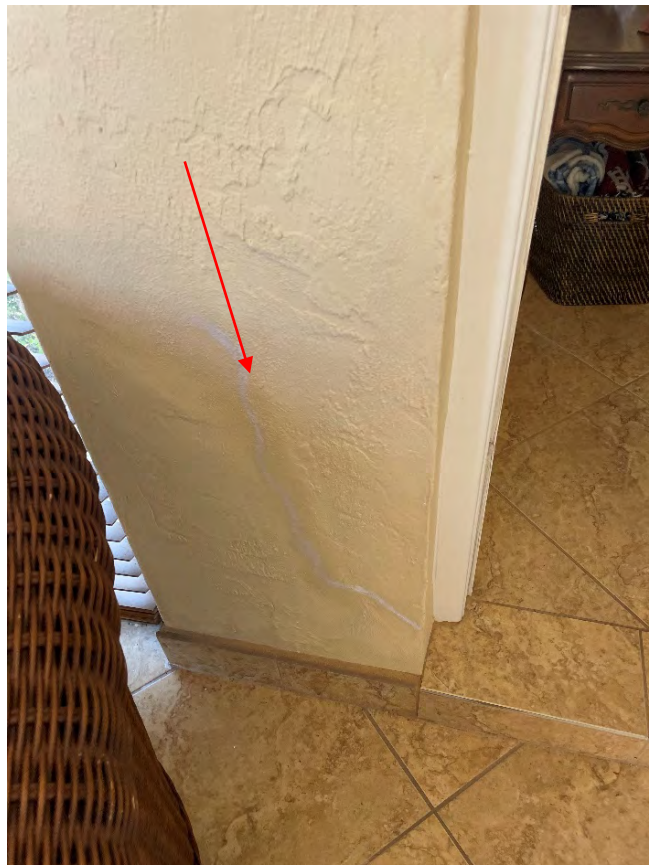
Figure 28 - Crack chased with sealant in Unit 108

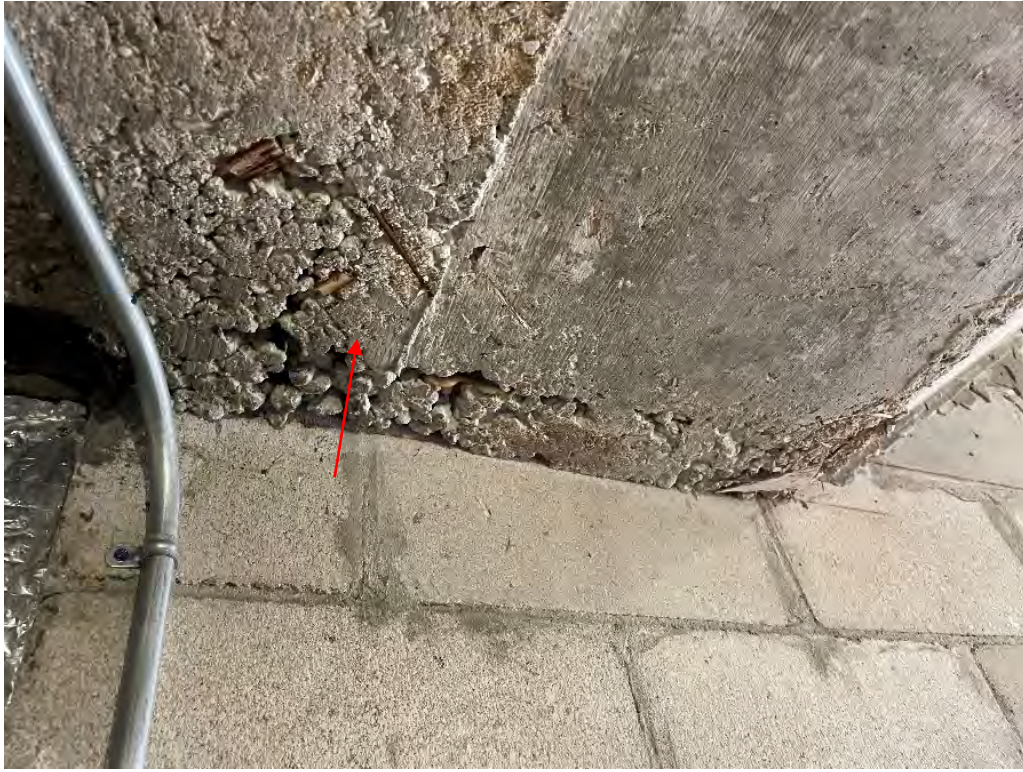
Figure 29 – Honeycombing in concrete in mechanical room

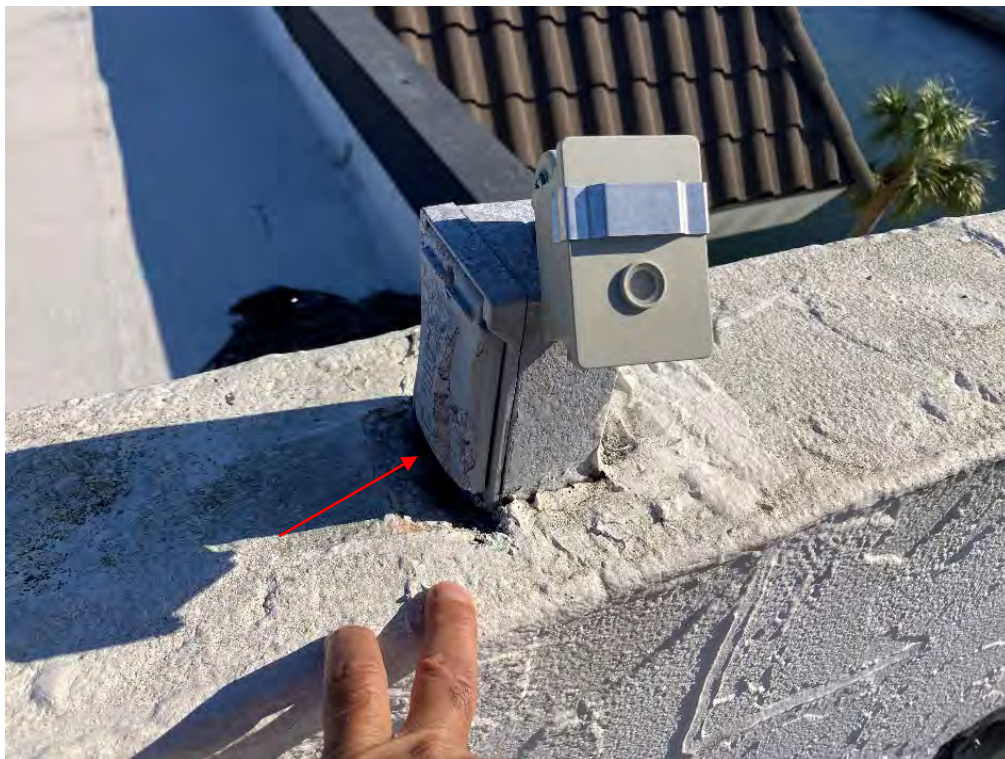
Figure 30 - Extrusion to be sealed properly
