Milestone Inspection Report

Project #23RS-0013
July 24th 2023
FINAL COPY

RE: *Longboat Harbour Structural Evaluation*
4454 Gulf of Mexico Drive, Longboat Key, FL 34228
KE File # 23RS-0013
Professional Engineering Services – Milestone Inspection, Structural Integrity Reserve Study

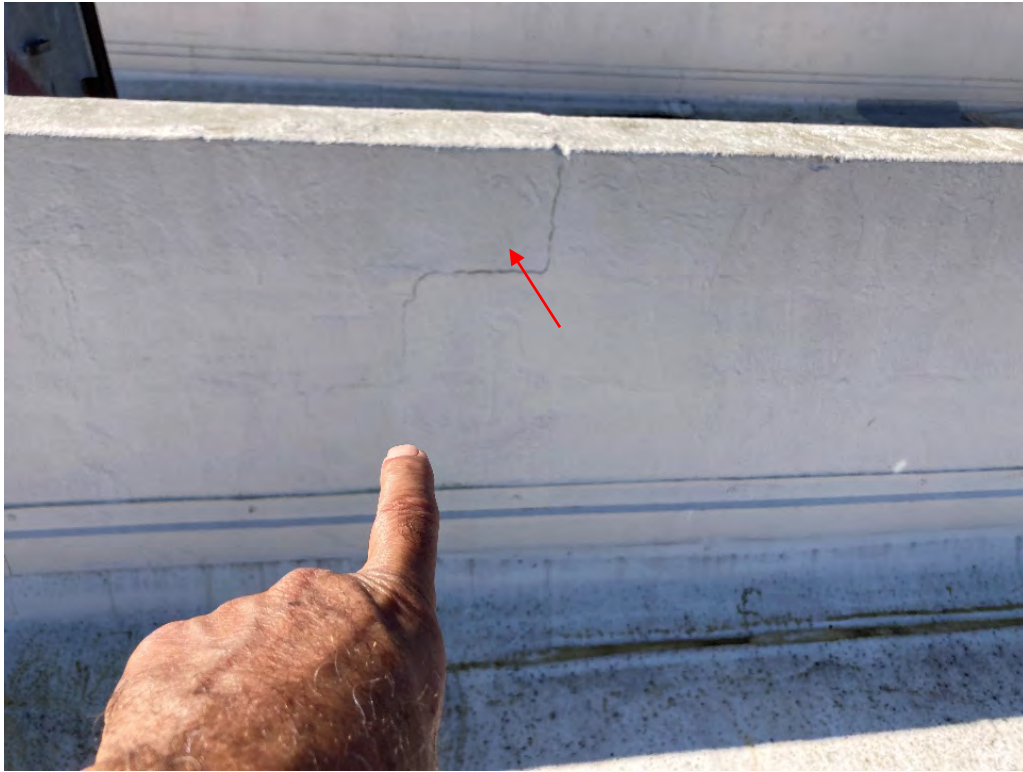
Figure 31 - Stair-stepping in rooftop parapet wall

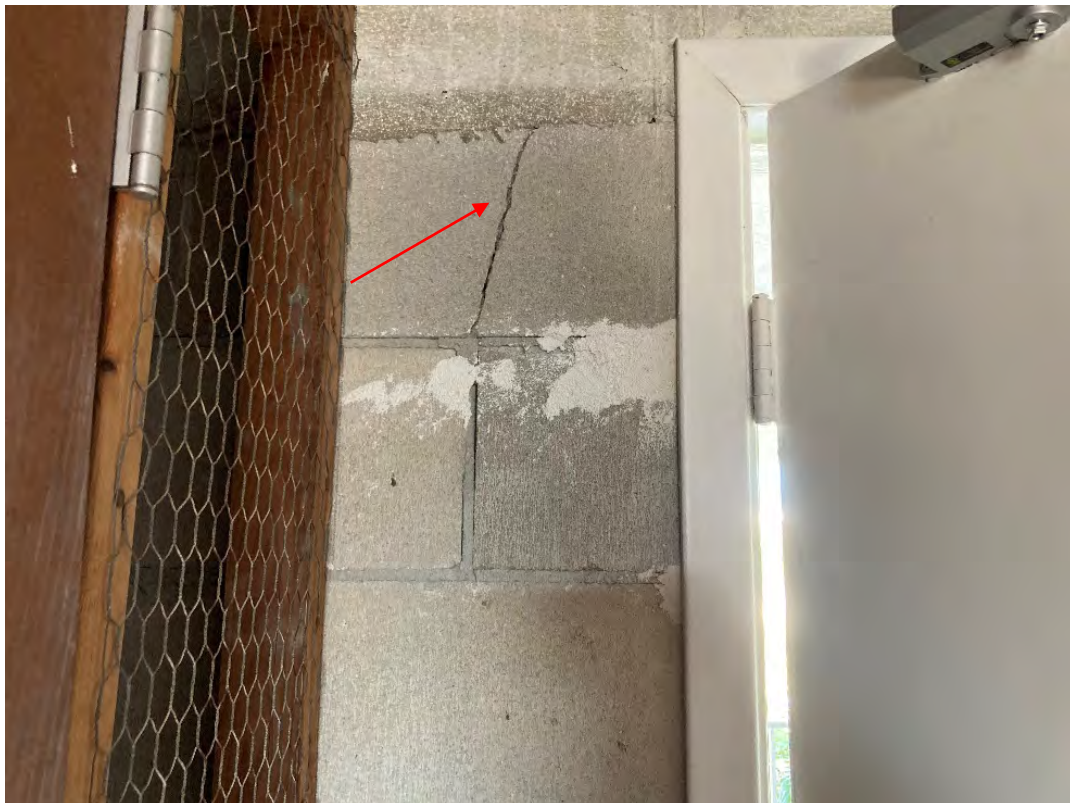
Figure 32 - Cracking in CMU wall in storage room

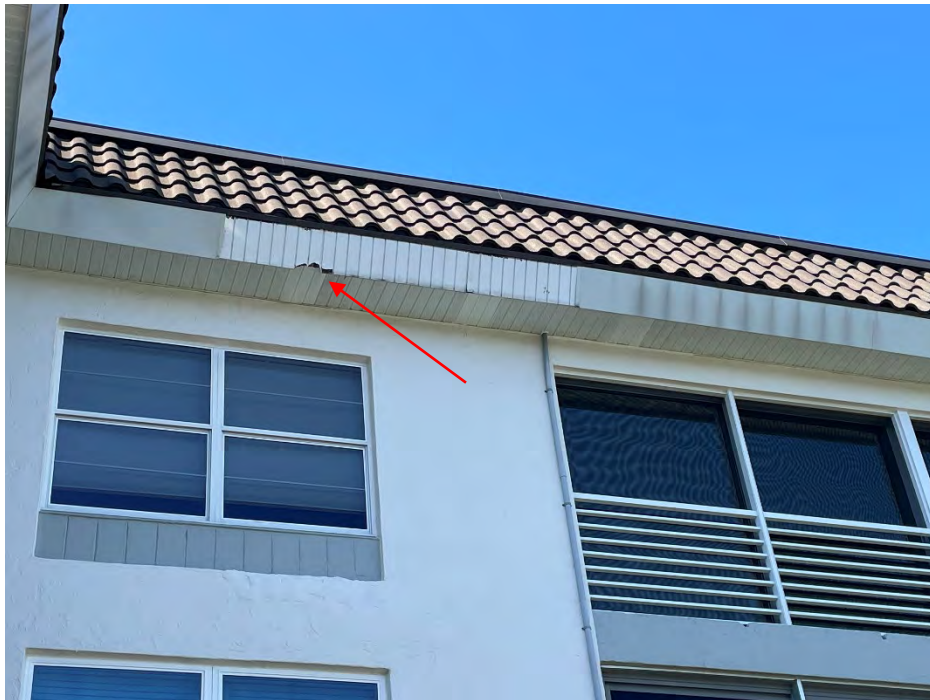
Figure 33 - Damaged fascia on exterior of the building

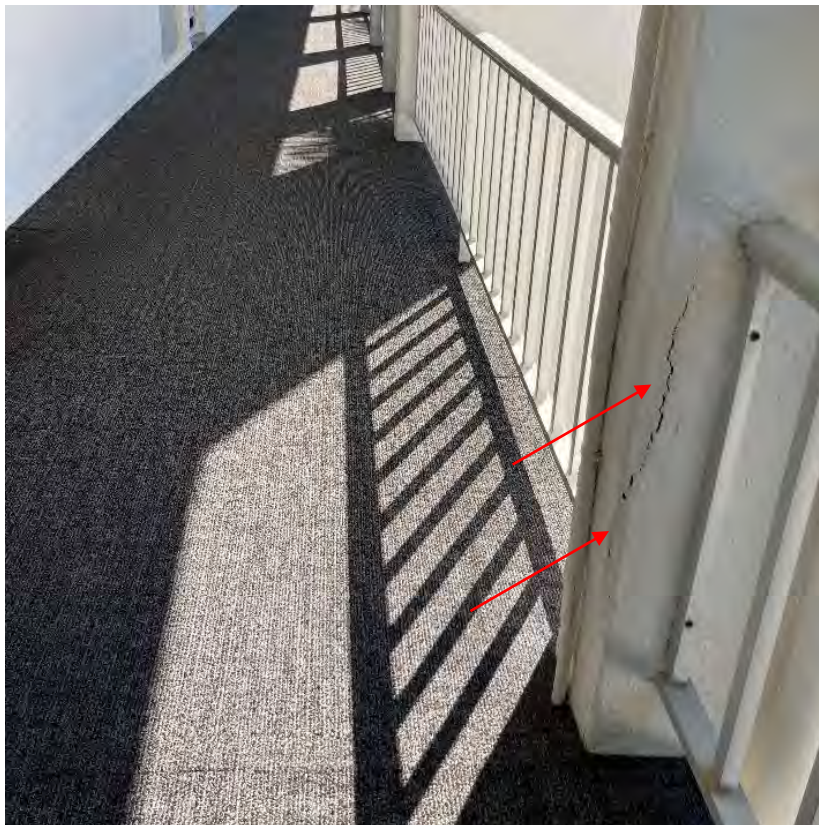
Figure 34 - Spalling on column on 3rd floor

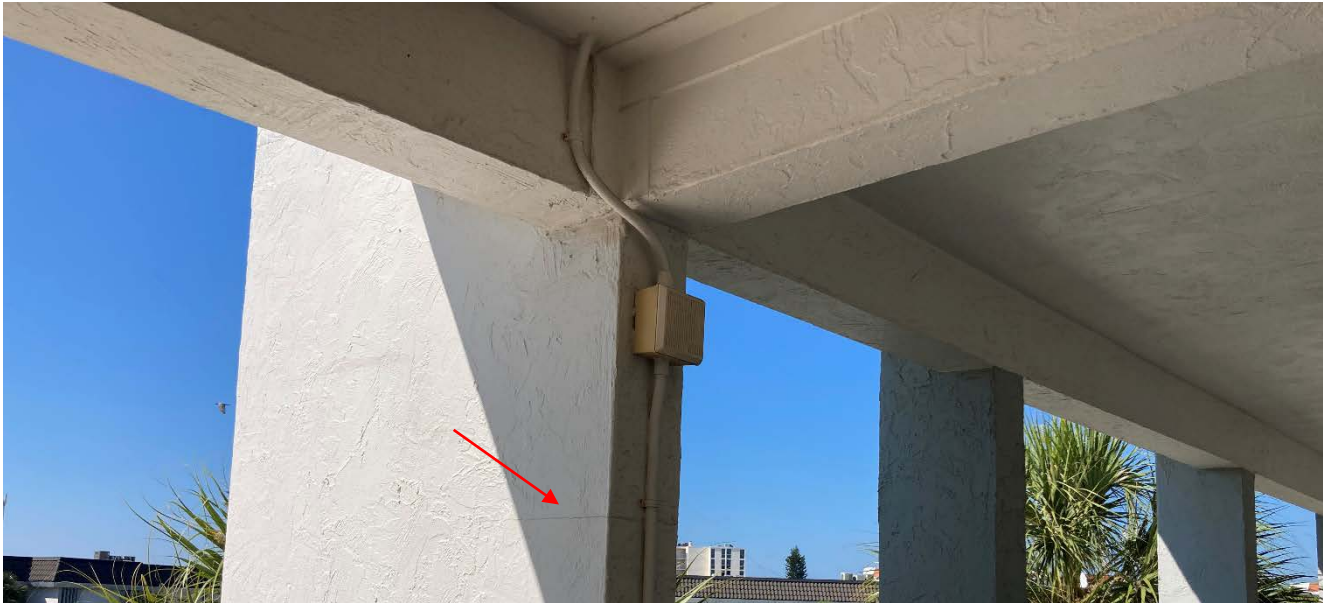
Figure 35 - Cracking on column on 3rd floor

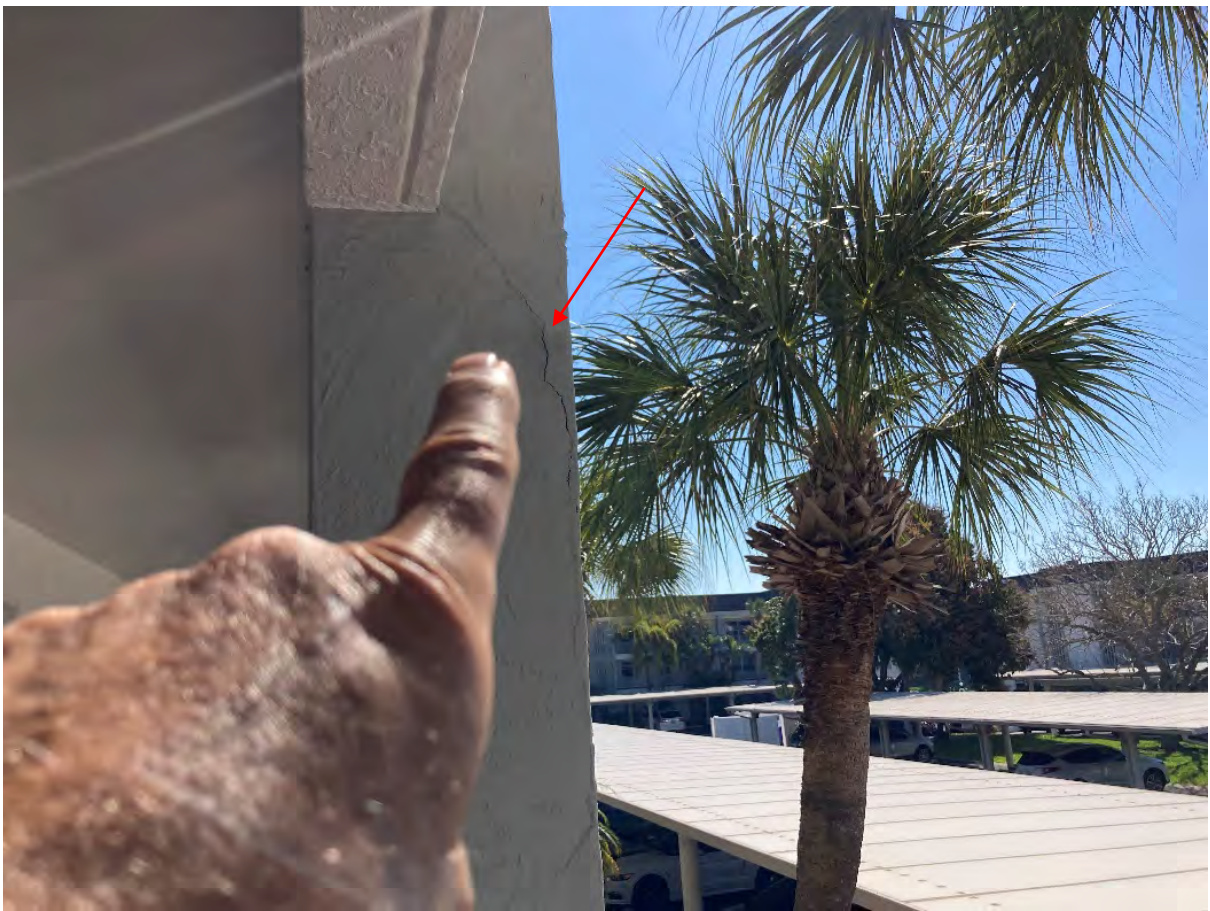
Figure 36 - Cracking on column on level two

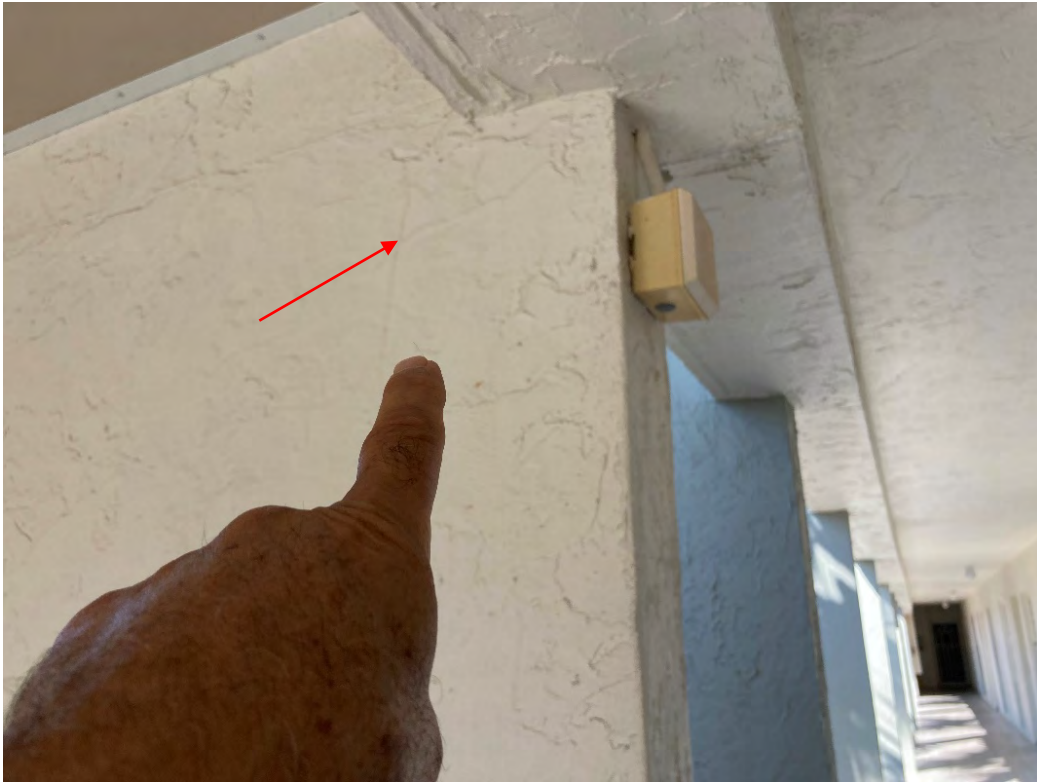
Figure 37 - Cracking on column on level one

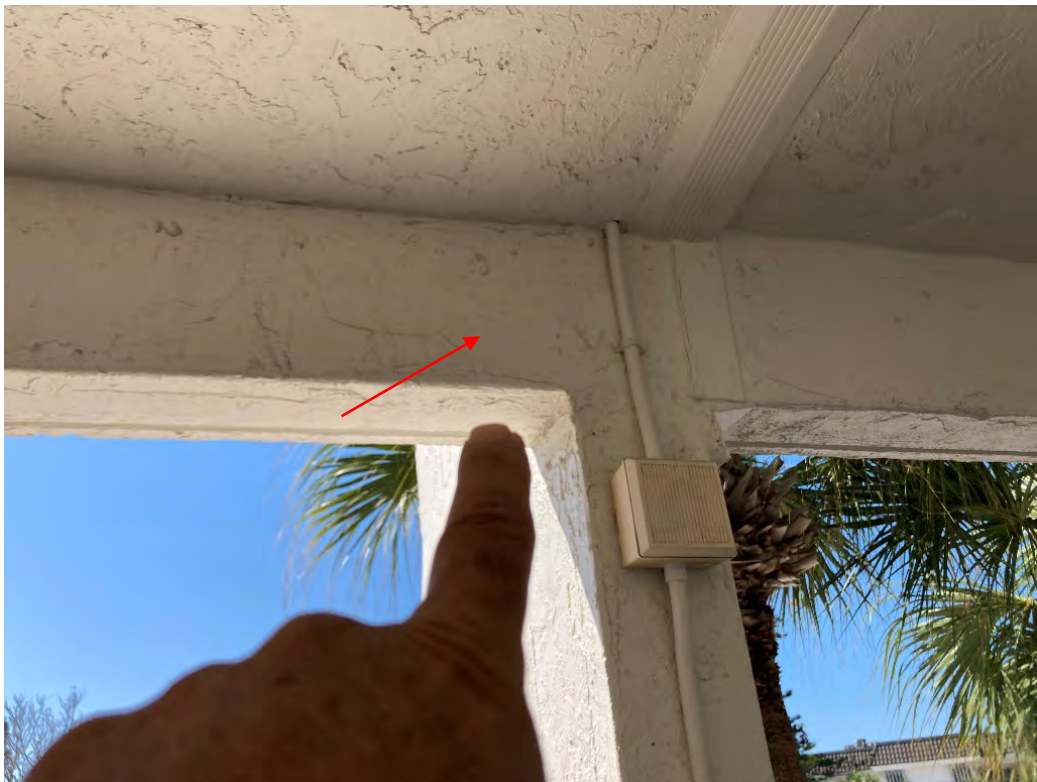
Figure 38 - Cracking on beam on level three

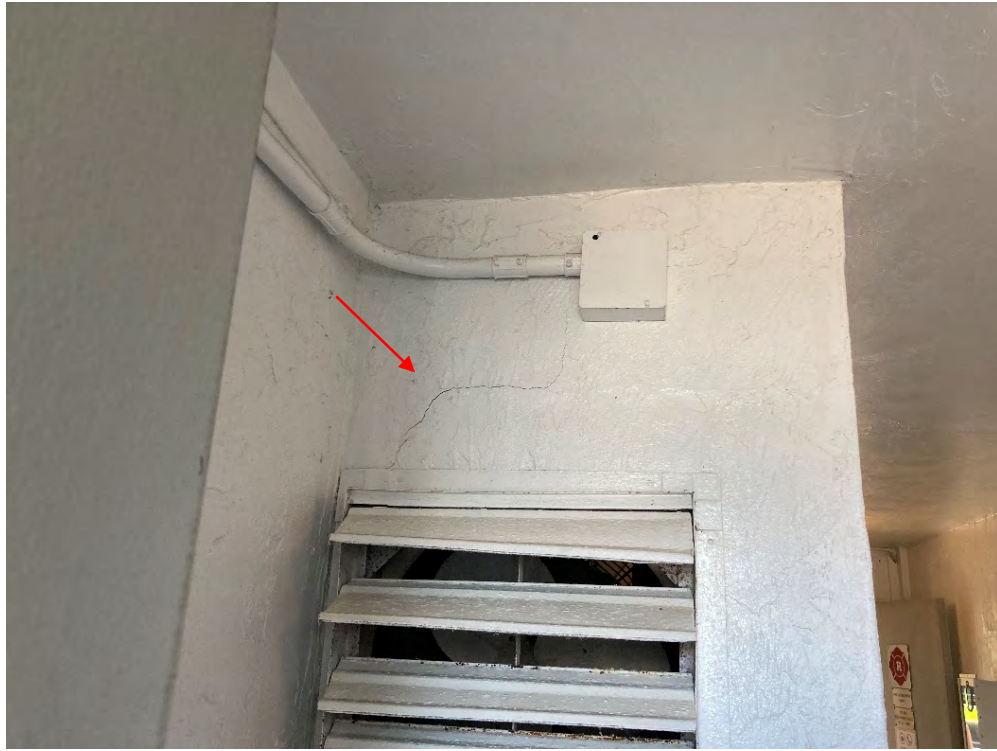
Figure 39 - Stair-stepping on ground floor

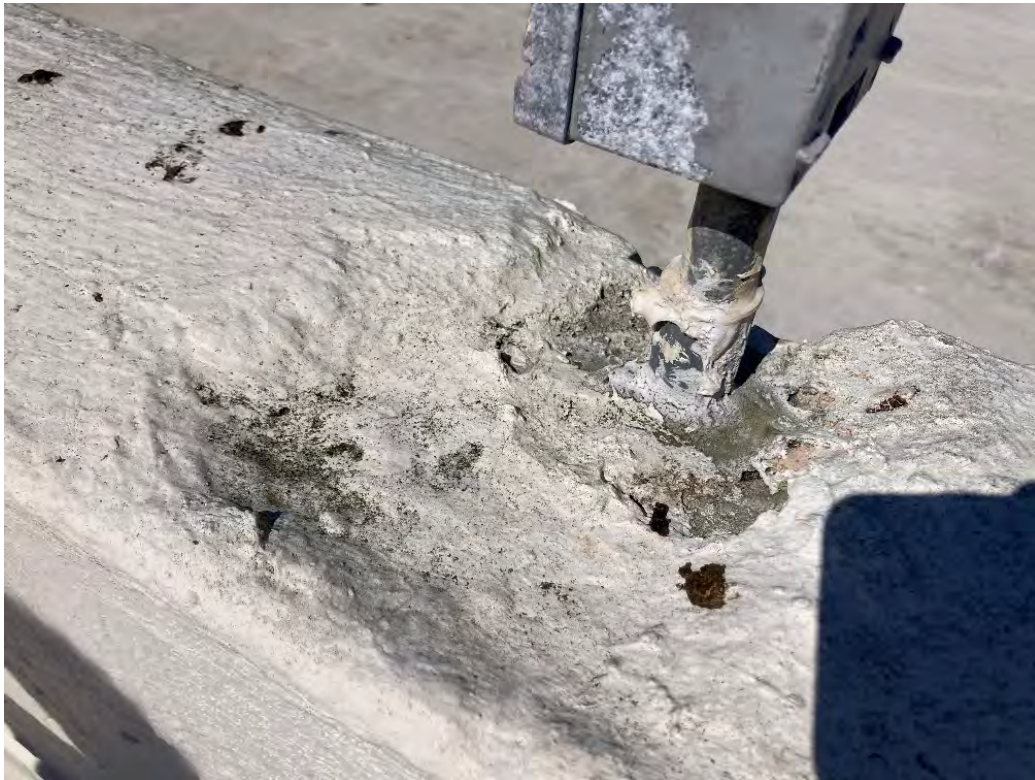
Figure 40 - Extrusion not properly sealed

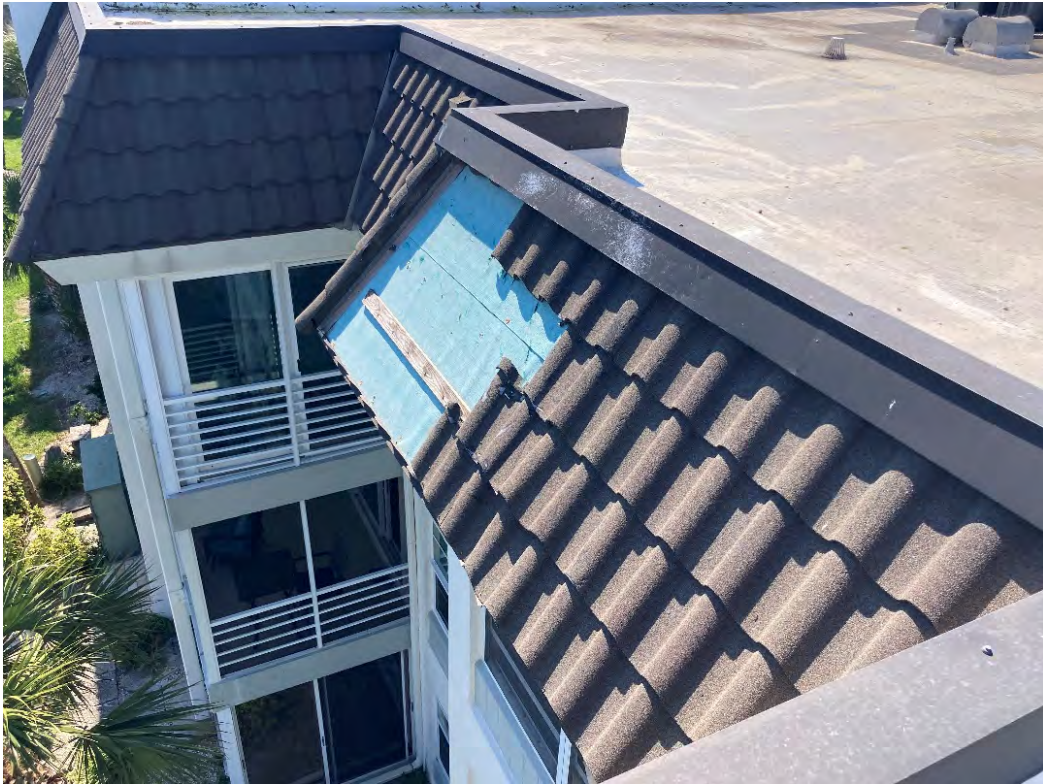
Figure 41 - Section of missing roof tiles

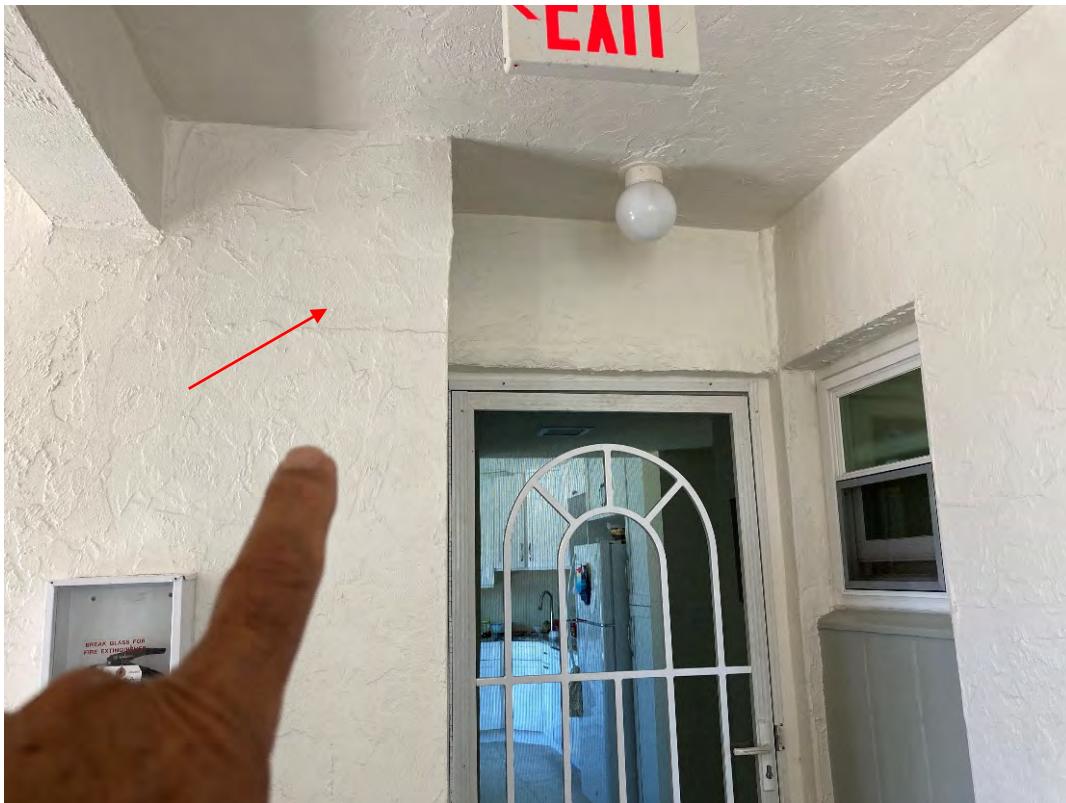
Figure 42 - Cracking in wall on 3rd floor

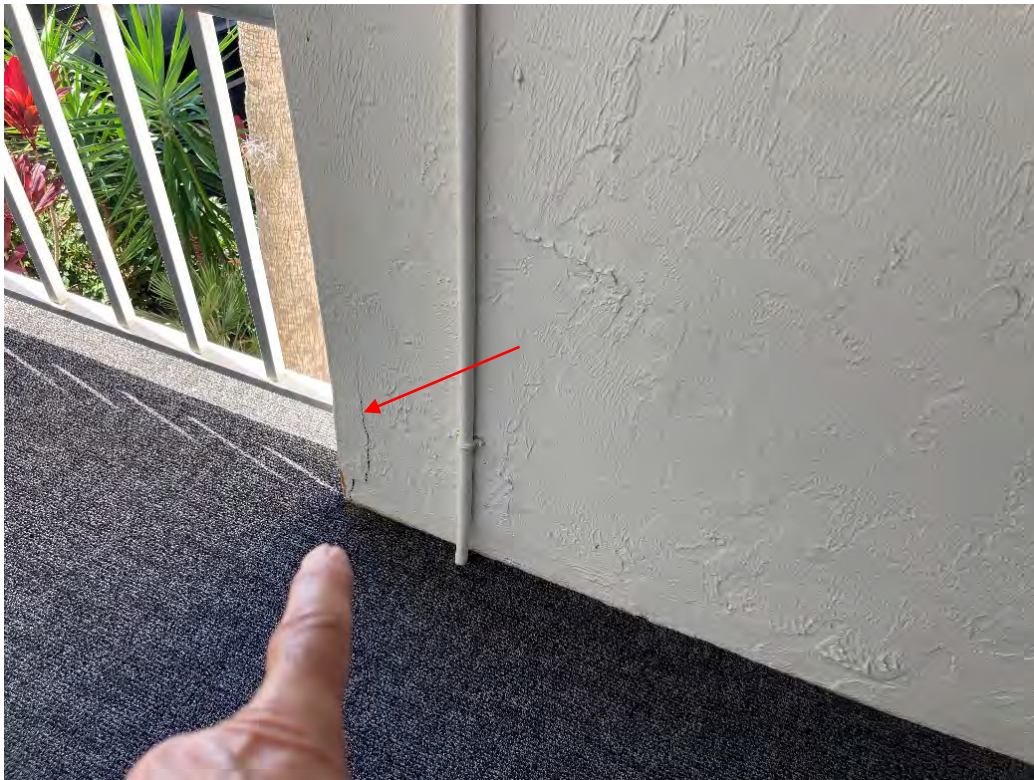
Figure 43 - Cracking in wall on level two

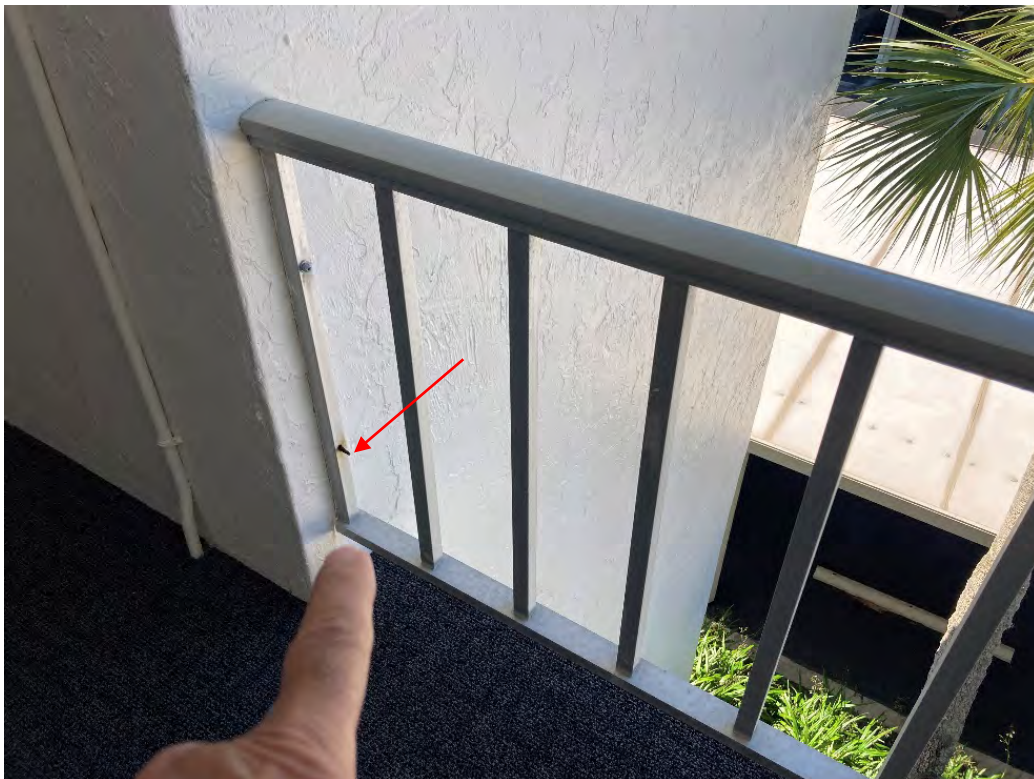
Figure 44 - Rusted walkway railing bolt on 3rd floor

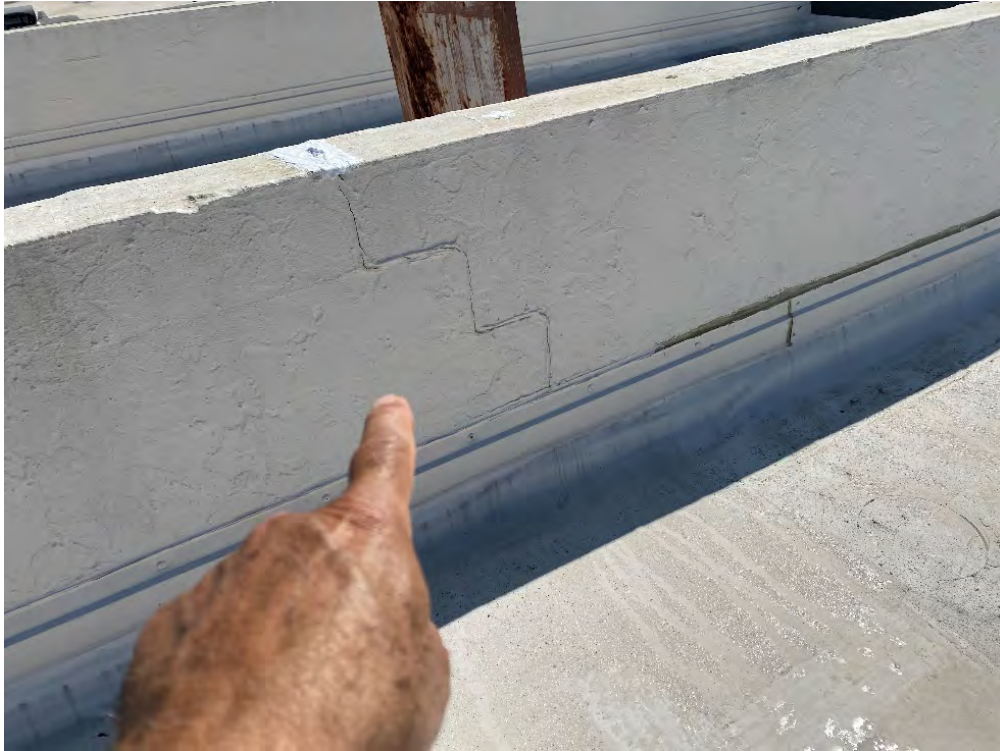
Figure 45 - Stair-stepping on parapet wall

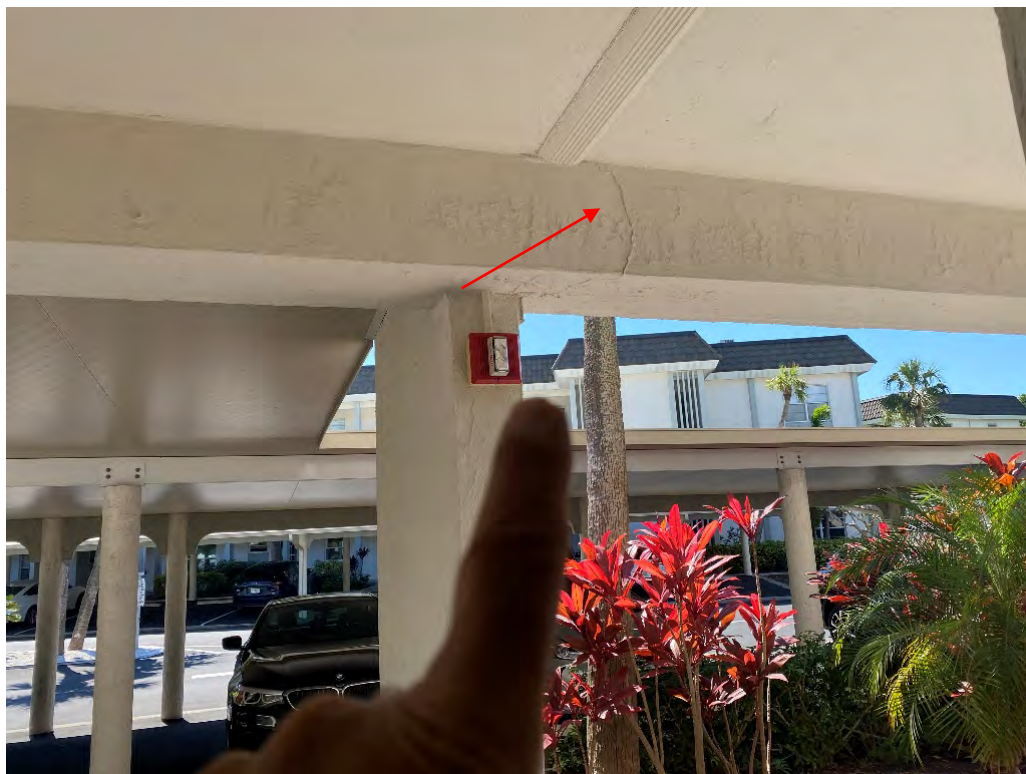
Figure 46 – Surface cracking on beam on the underside of level two

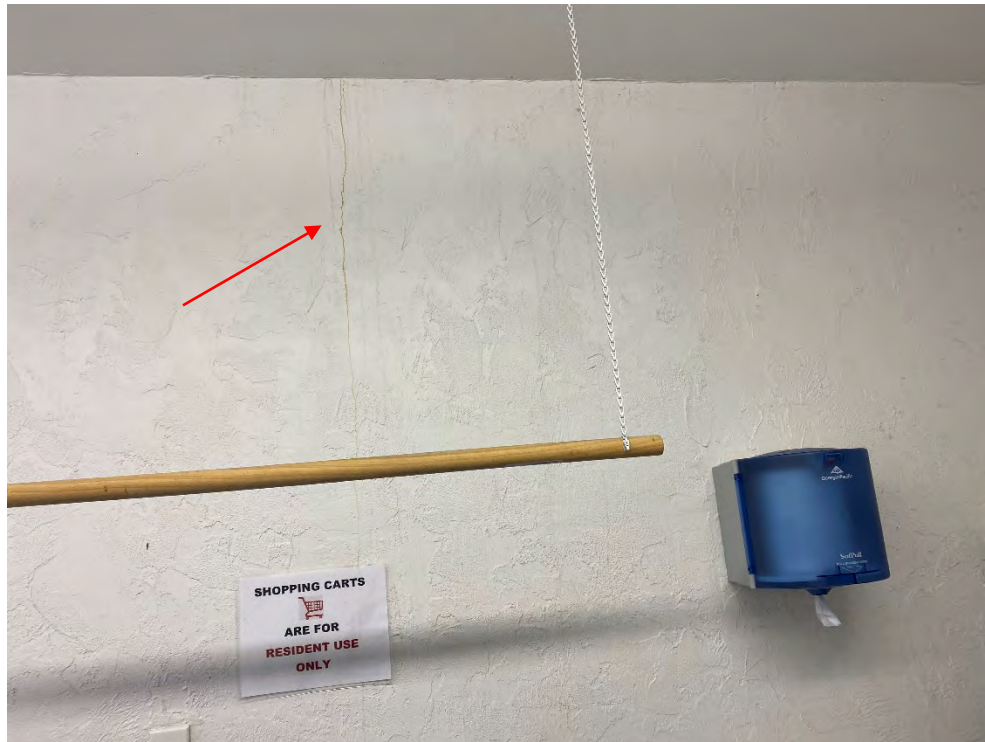
Figure 47 - Cracking on wall in laundry room
