Milestone Inspection Report

Project #23RS-0013
July 24th 2023
FINAL COPY

RE: *Longboat Harbour Structural Evaluation*
4454 Gulf of Mexico Drive, Longboat Key, FL 34228
KE File # 23RS-0013
Professional Engineering Services – Milestone Inspection, Structural Integrity Reserve Study

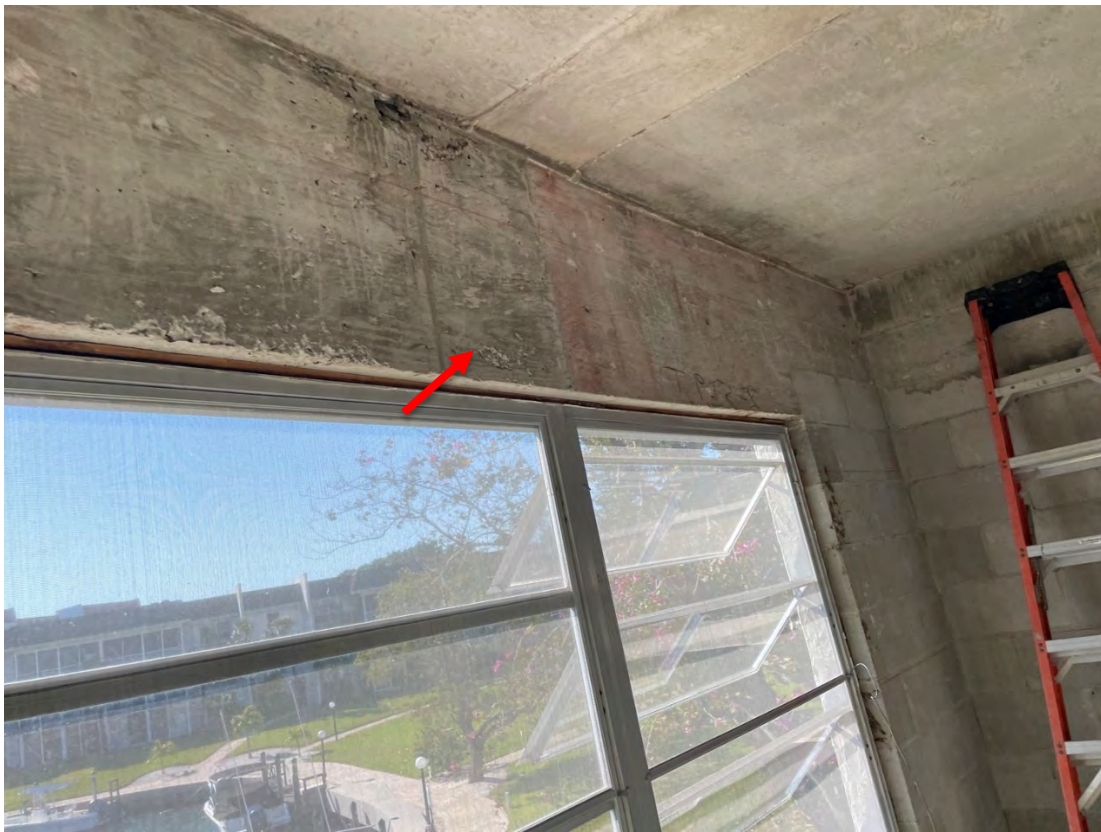
Observations: No observed structural deficiencies were noted. All observable beams were noted to be in good condition. The following photo shows the current condition of the beams observed around the property in a unit that had all interior finished removed for easy identification.

Figure 3: Typical Concrete Beams Observed.

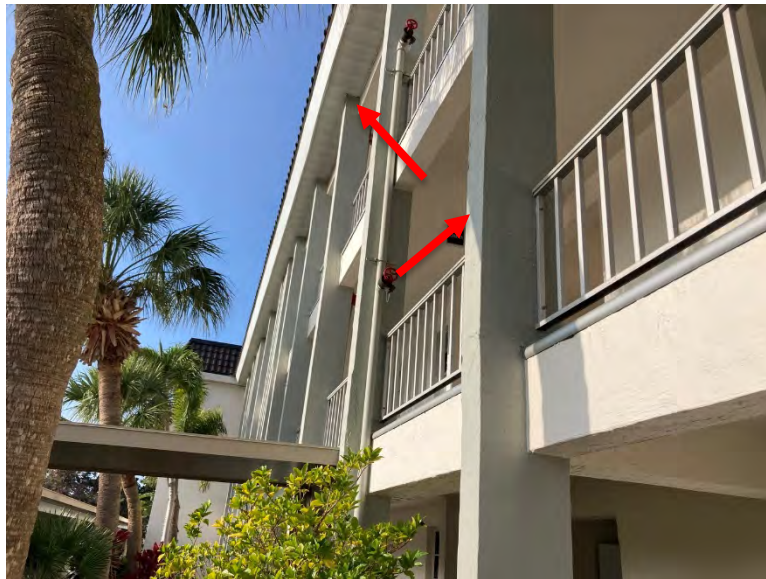
Figure 4: Typical columns observed.

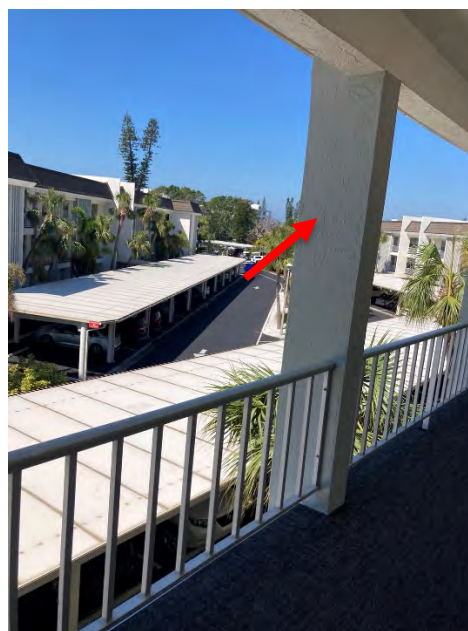
Figure 5: Typical columns observed.

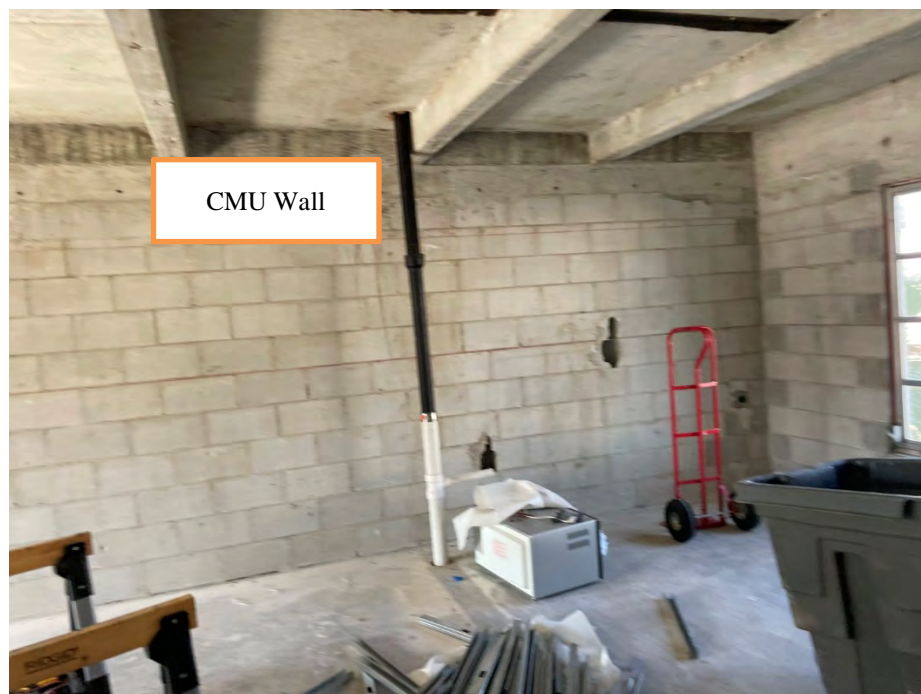
Observations: No structural deficiencies observed.

Figure 6: Example of CMU demising wall at Unit I 208

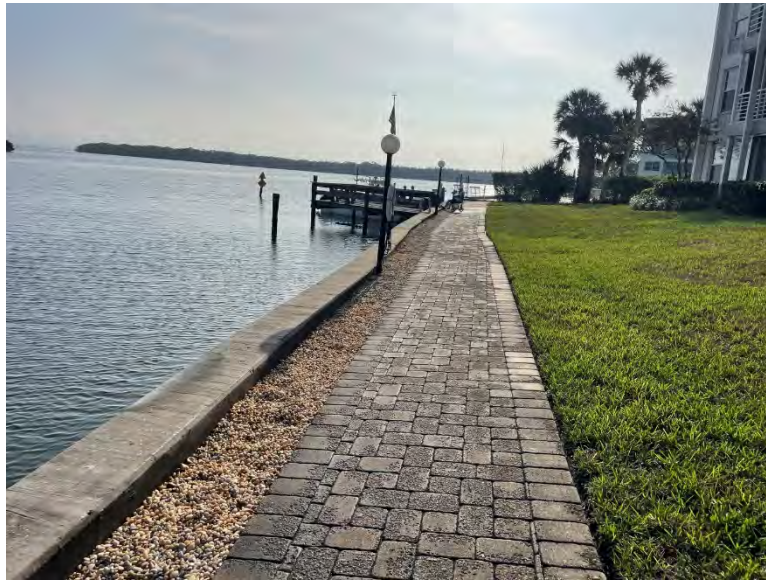
Figure 8: Seawall Observed.

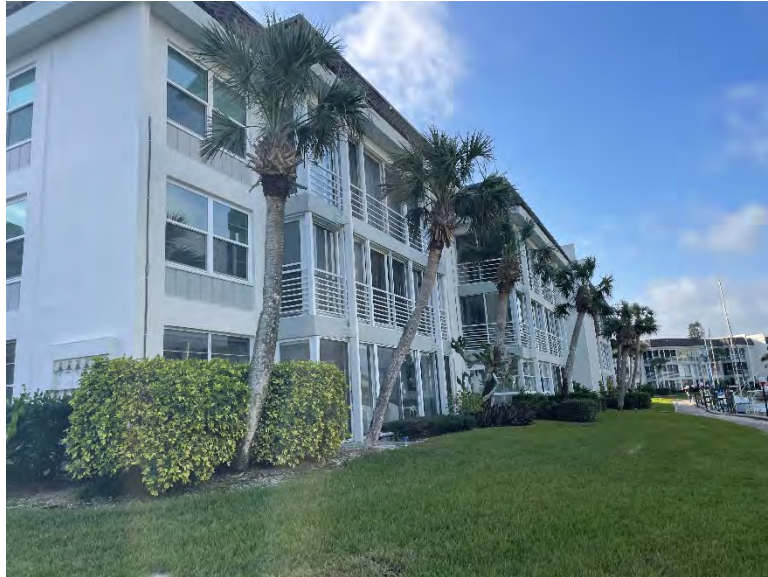
Figure 10: Typical building exterior overview.

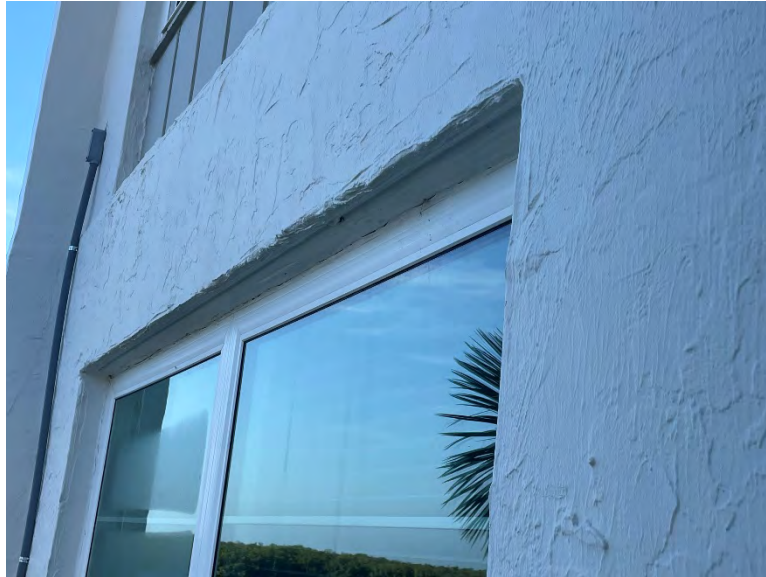
Figure 11: Typical exterior window overview.

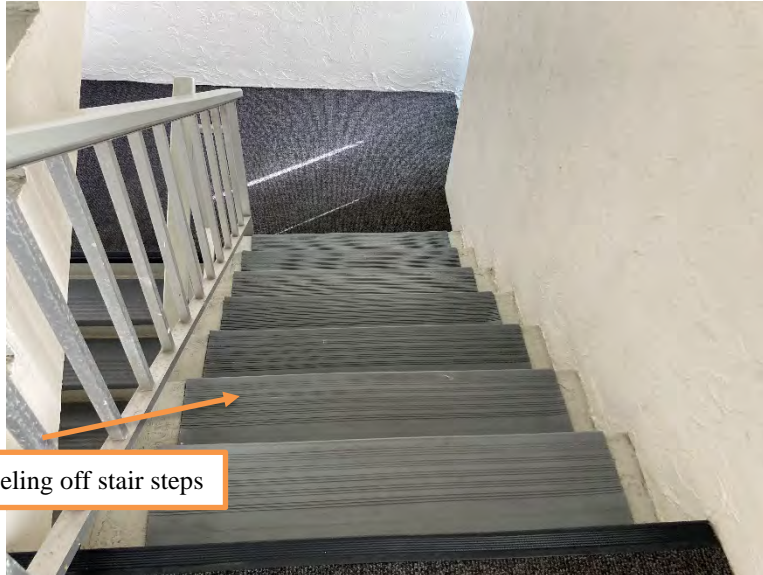
- Traction tracks attached to stair steps appear to be becoming loose in some locations.

Figure 13: Typical stairwell overview.

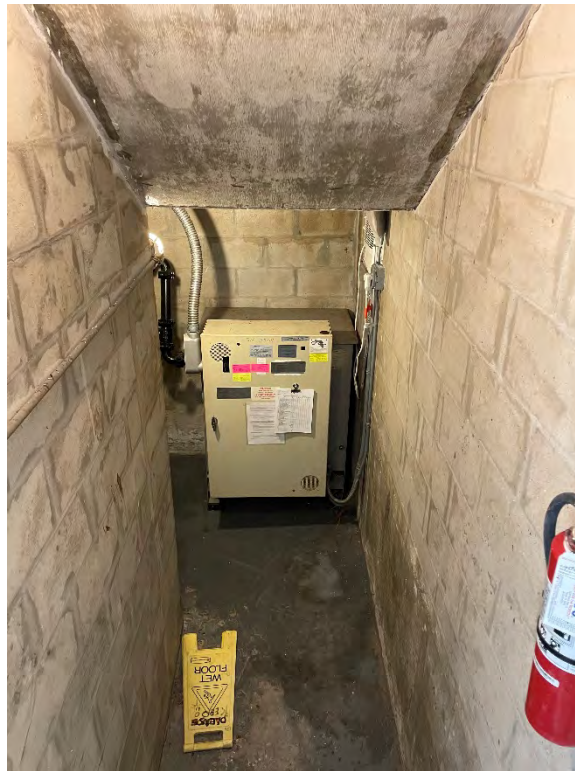
- Sloped ceilings experiencing deteriorating conditions in some buildings' mechanical rooms.

Figure 14: Typical mechanical room overview.
